NATIONAL AERONAUTICS AND SPACE ADMINISTRATION
MANNED SPACECRAFT CENTER • HOUSTON, TEXAS

GEMINI PROGRAM MISSION REPORT

GEMINI 2

MSC-G-R-65-1

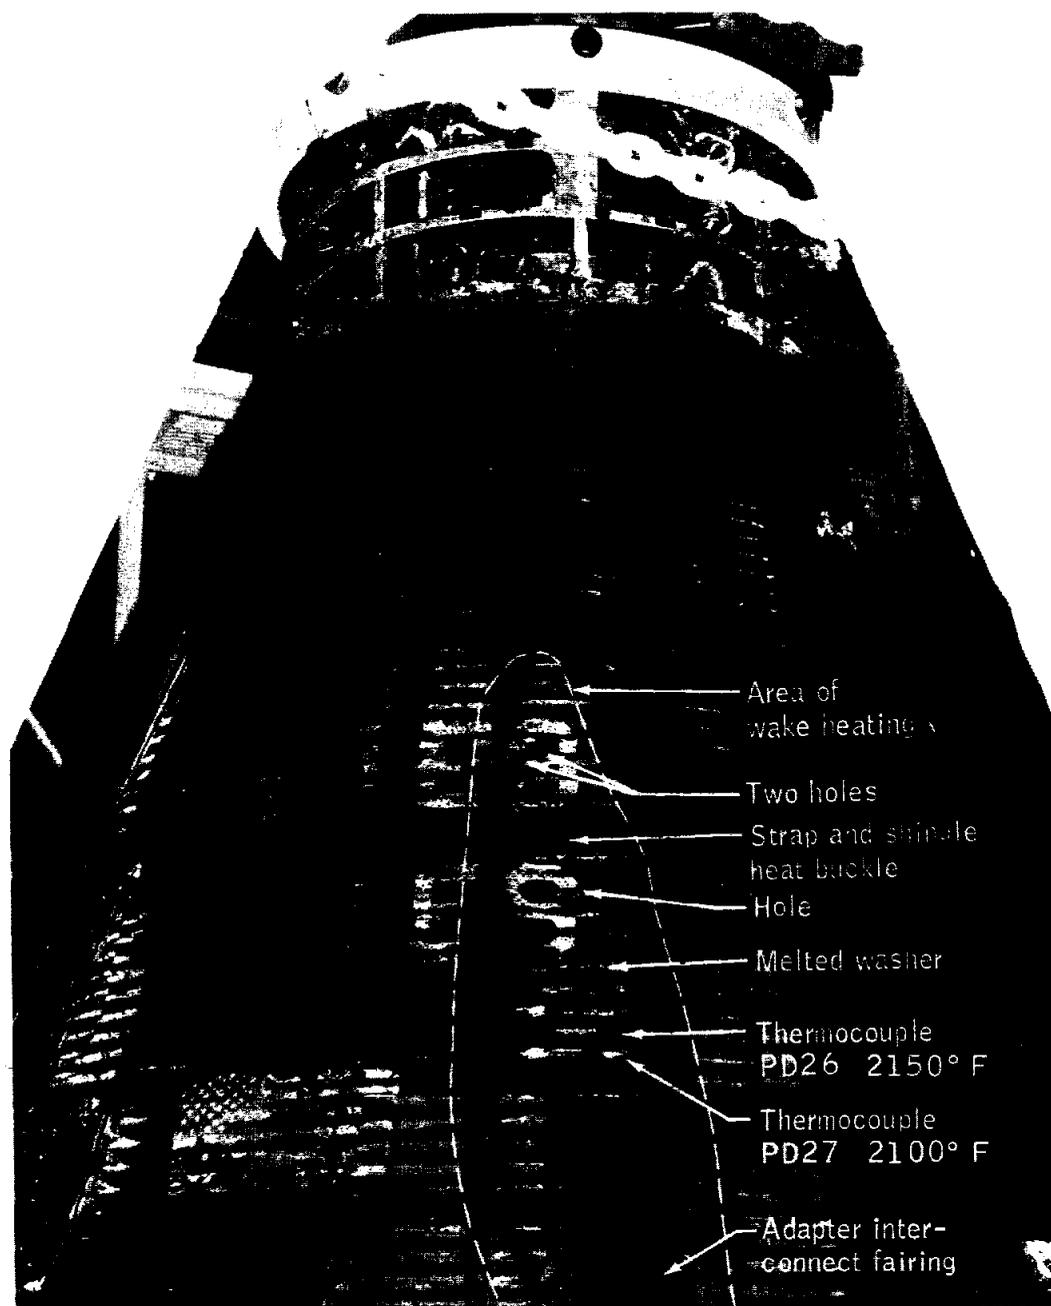
Local heating caused burn-through of four holes $\frac{1}{8}$ to $\frac{3}{8}$ -inch diameter in two shingles 14 to 25 inches downstream in the wake of the windward adapter interconnect fairing. Plastic flow and surface melting also occurred in this area. No damage of underlying insulation or structure occurred other than temperature discolorations.

Figure 5.1-14. - Region of damage in wake of most windward interconnect fairing

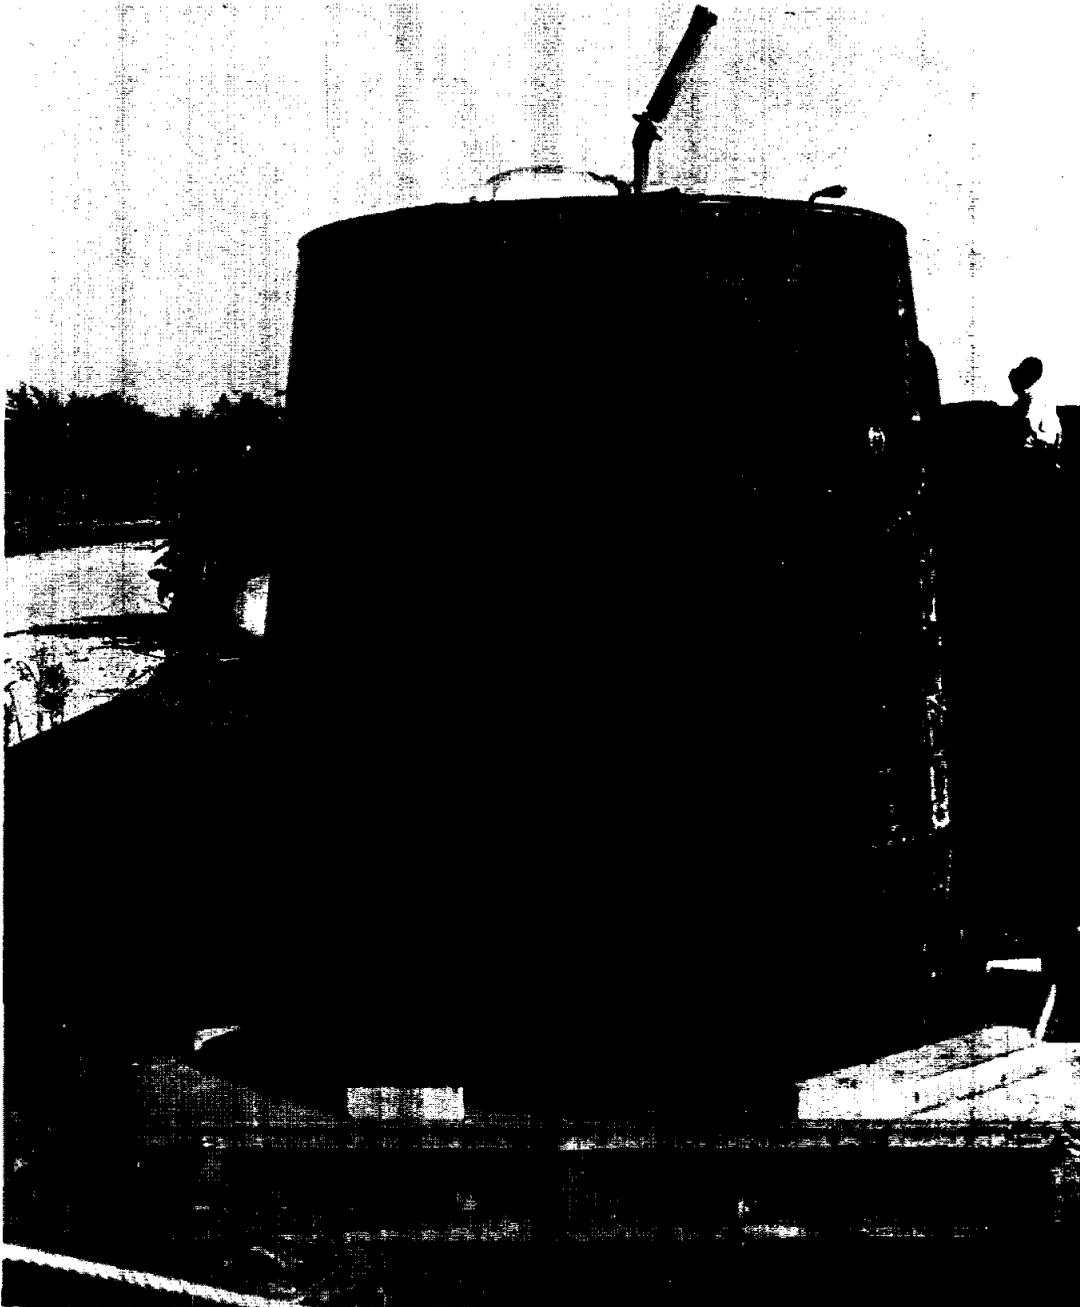
Figure 12-13. - R and R section and bent stub antenna
