GEMINI PROGRAM MISSION REPORT

GEMINI IV

JUNE 1965

NATIONAL AERONAUTICS AND SPACE ADMINISTRATION ☐ MANNED SPACECRAFT CENTER

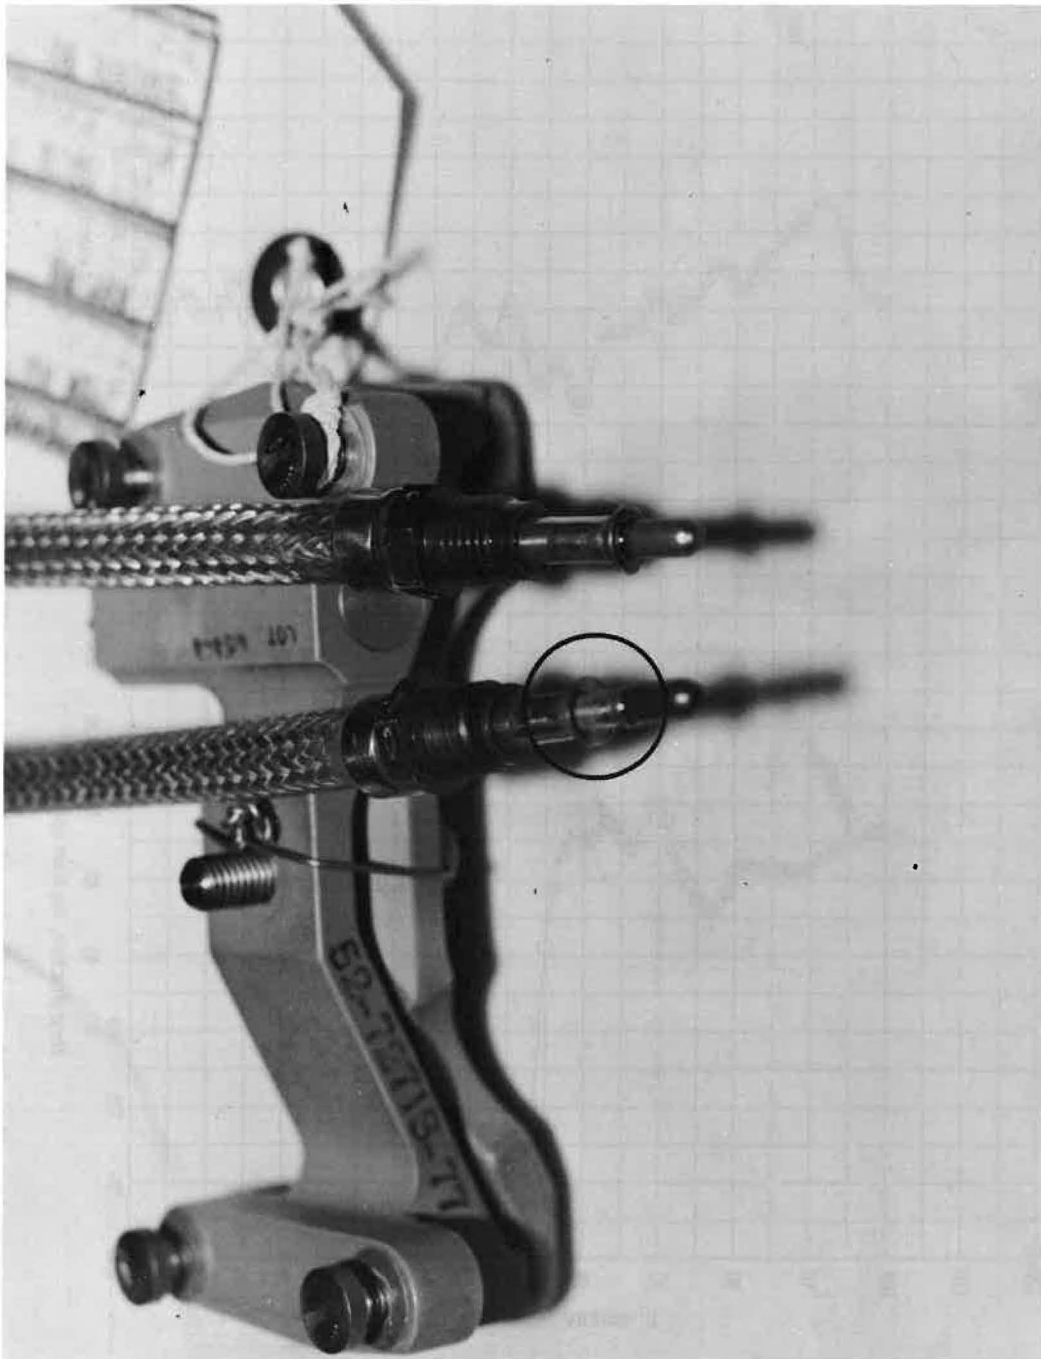
Figure 12-9. - Faulty escape system MDF interconnect.

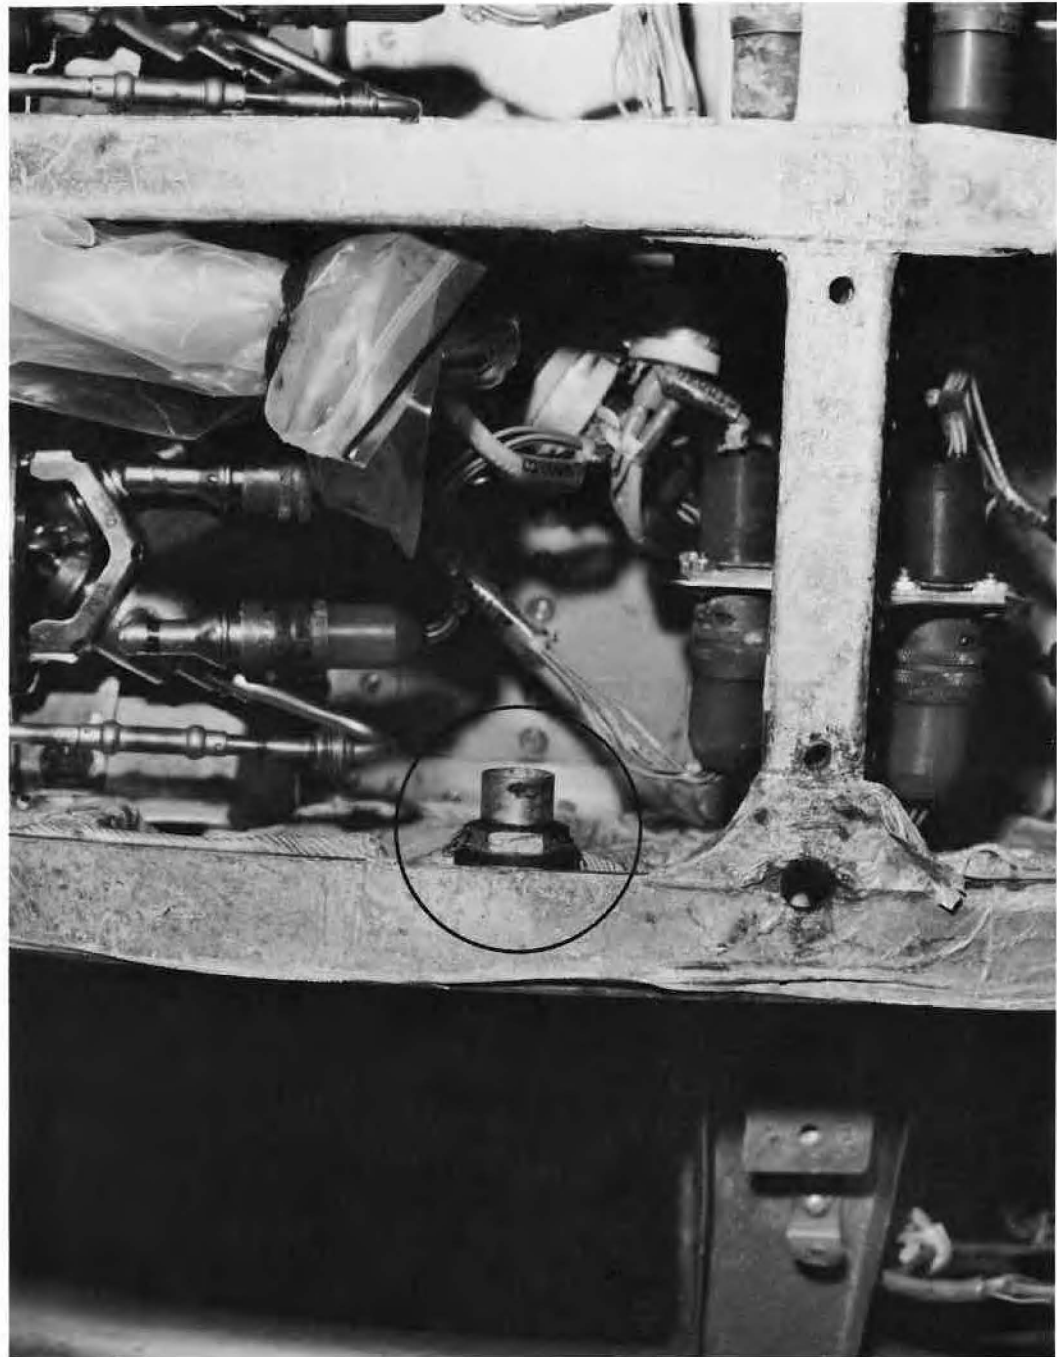
Figure 12-10 - Sheared connector to R and R separation igniter.
