MSC-G-R-65-2

GEMINI PROGRAM MISSION REPORT

GT-3
GEMINI 3
(U)

APRIL 1965

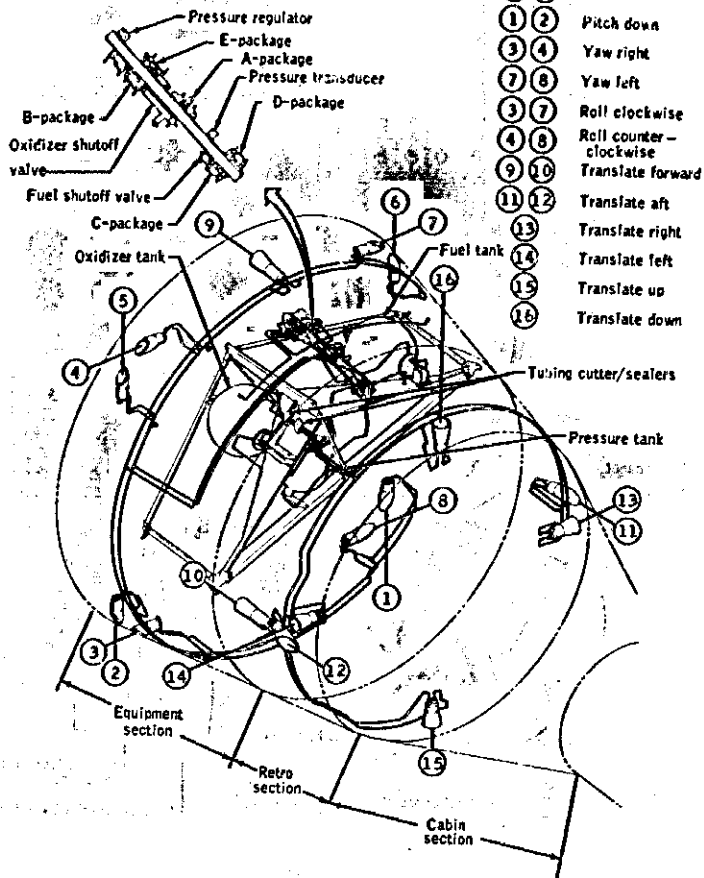
Figure 3-8. - Orbital attitude and maneuver system.

3.1.2.7.1 Orbital attitude and maneuver system: In the orbital attitude and maneuver system (OAMS), shown in figure 3-8, the four radial-thrusting (translation) thrust chamber assemblies (TCA's) were replaced by dummies. Also, two burst diaphragms normally installed in component package B were deleted.

NOTE
TCA 13, 14, 15, and 16
inoperative on spacecraft 3
