# THE MERCURY - REDSTONE PROJECT

SATURN/APOLLO SYSTEMS OFFICE

December 1964

SATURN/APOLLO SYSTEMS OFFICE  
GEORGE C. MARSHALL SPACE FLIGHT CENTER  
NATIONAL AERONAUTICS AND SPACE ADMINISTRATION  
HUNTSVILLE, ALABAMA

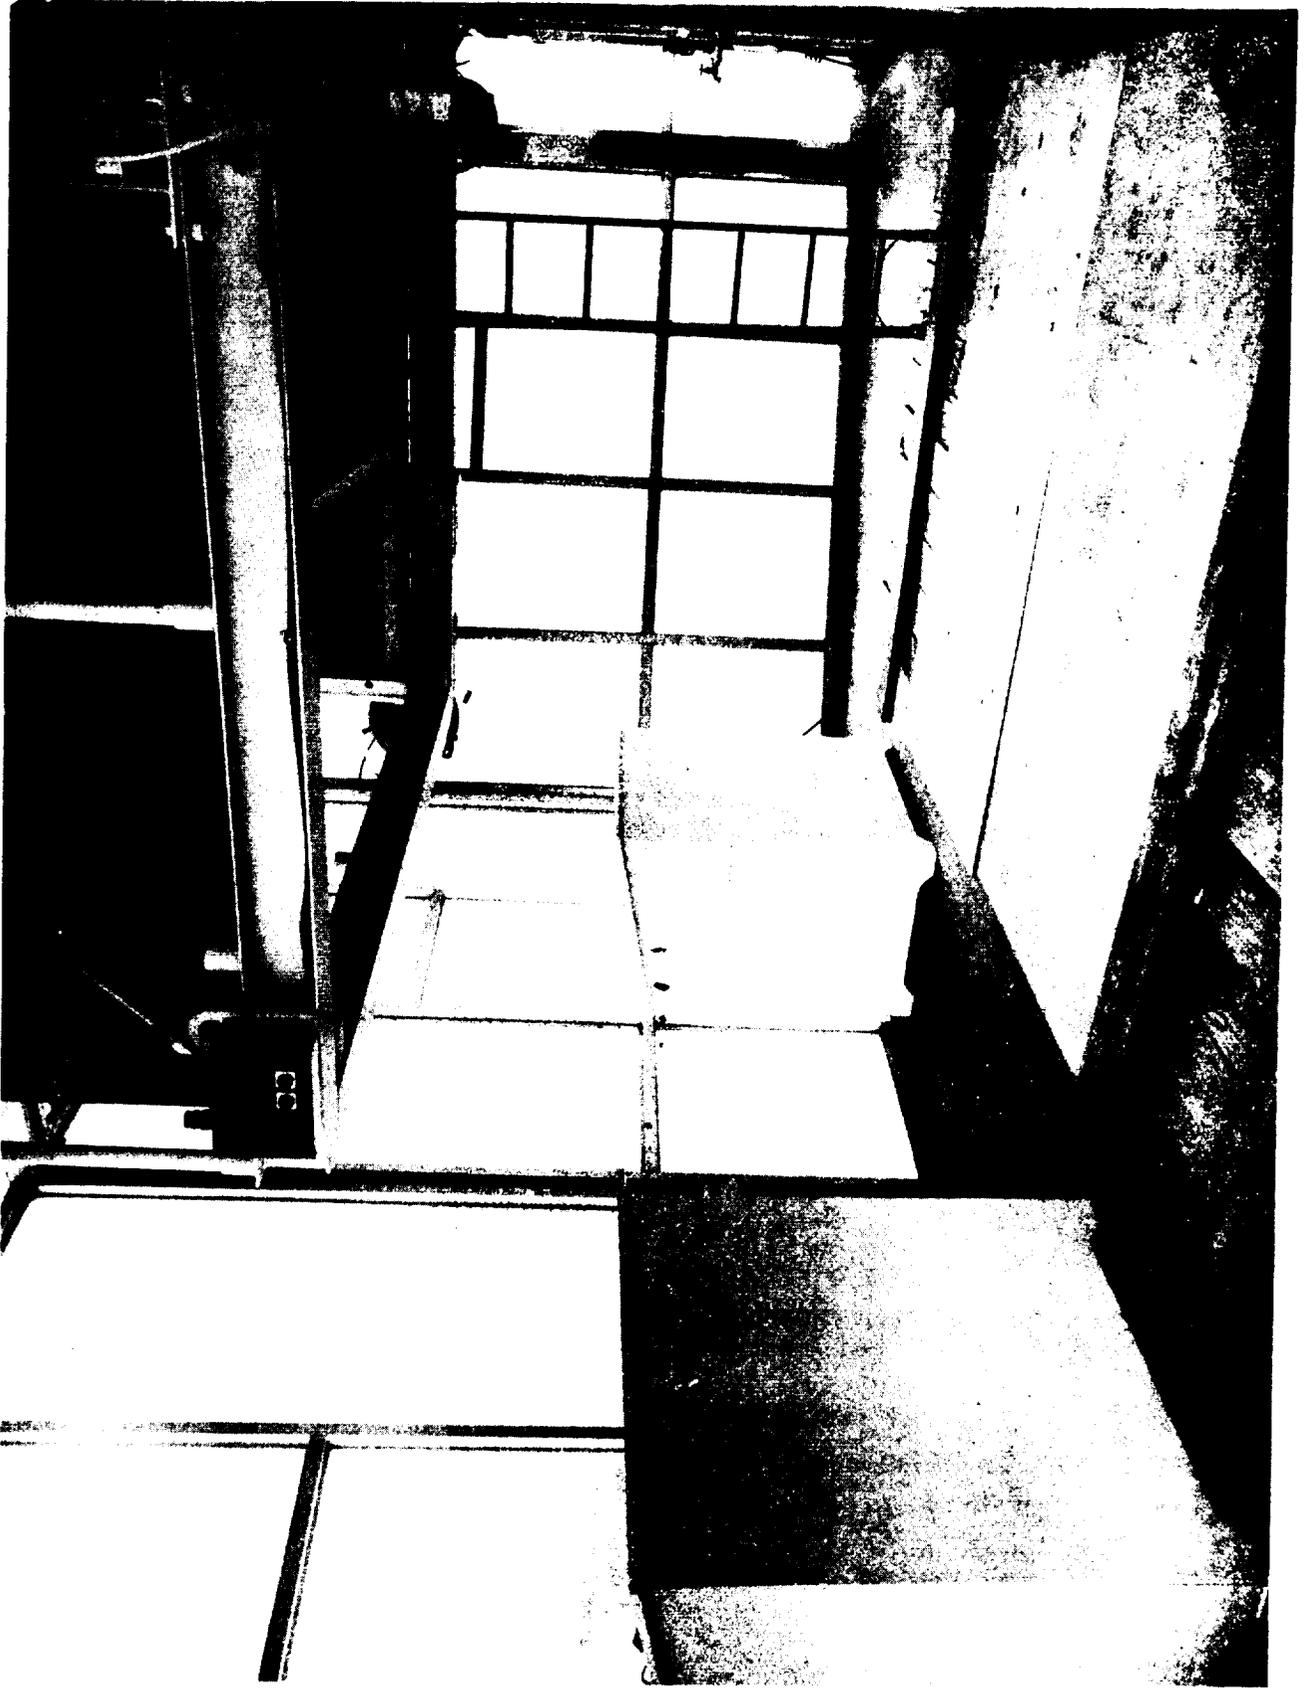
Figure 7-11. Auxiliary Platform, White Room, Service Structure, VLF 56

Platform three was designed for load limits of 10 personnel (2000 pounds) and 500 pounds of equipment. During the first mating of MR-1 at CCMTA, it was observed that these load limits were exceeded and that the platform was being deflected. Investigation revealed that platform loads were approximately 4000 pounds with greater loads to be
