**RESULTS OF THE
FIRST UNITED STATES
MANNED ORBITAL SPACE FLIGHT
FEBRUARY 20, 1962**

NATIONAL AERONAUTICS AND SPACE ADMINISTRATION

**MANNED SPACECRAFT CENTER
NATIONAL AERONAUTICS
AND SPACE ADMINISTRATION**

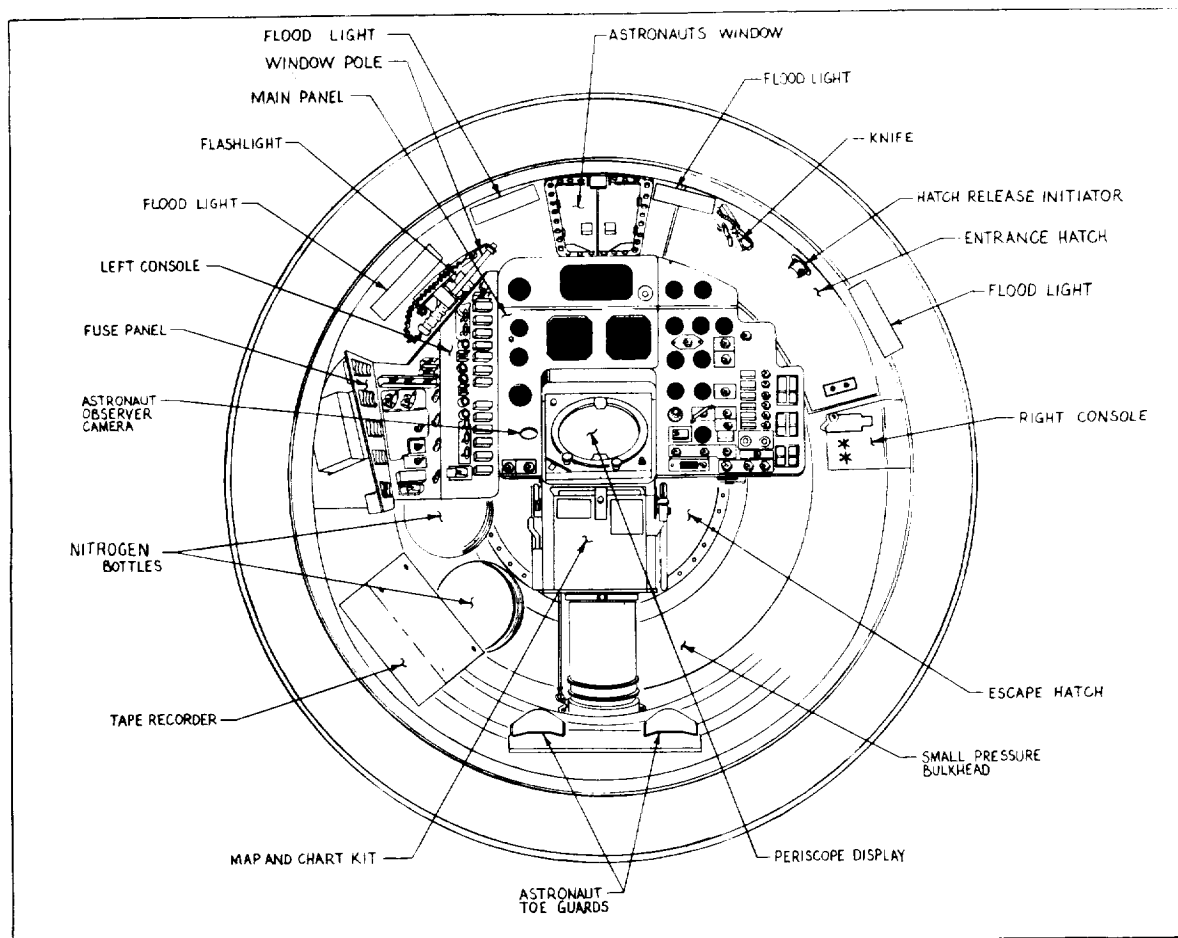
A window is provided, in the conical section over the astronaut's head, for the astronaut to use for observations and for obtaining visual attitude references. The astronaut entrance and egress hatch is located in the conical section as indicated by the outline to the astronaut's right. The astronaut can also egress through

FIGURE 2-3.—Spacecraft cabin arrangement.

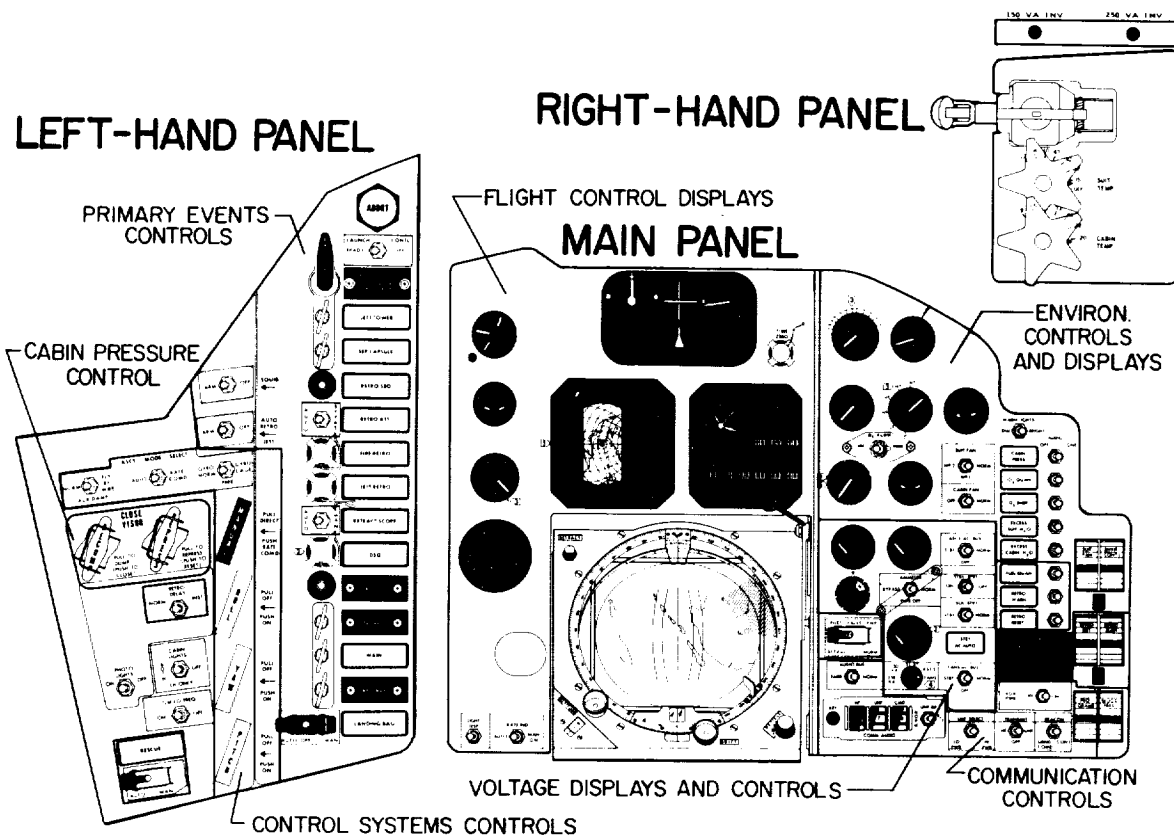
FIGURE 2-4.—Instrument panels.

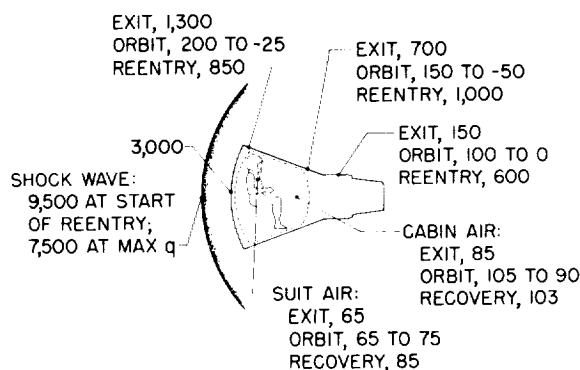
During the exit flight, when the small end of the spacecraft points in the direction of flight, the afterbody shingles are also subjected to aerodynamic heating, attaining maximum temperatures as high as about 1,300° F. With the local temperatures dependent upon local flow conditions and the thermal mass of the spacecraft surface.

The temperature variation of the outer shingles around the astronaut's pressure compart-

FIGURE 2-7.—Representative temperatures in degrees Fahrenheit.

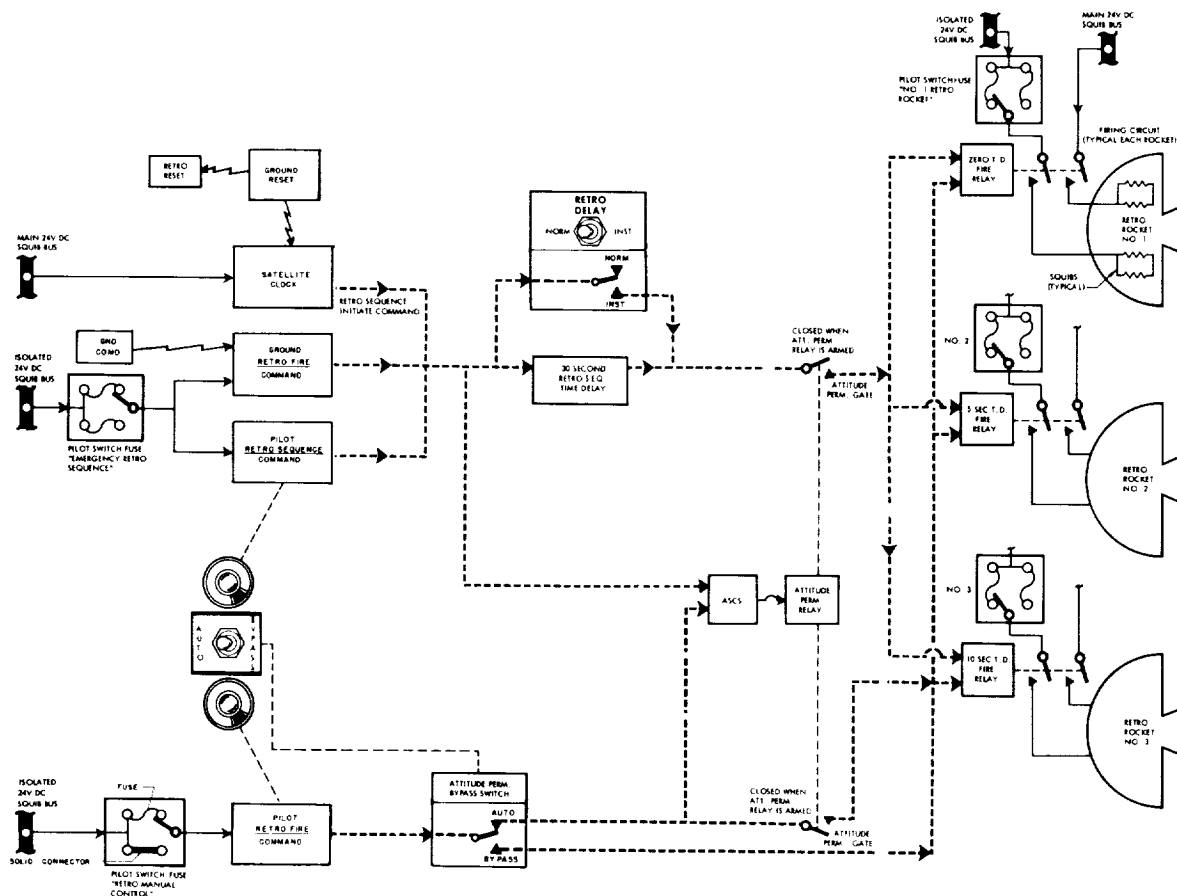
All rocket motors have dual ignition systems from separate electrical power sources. In addition, each ignition system has dual squibs

FIGURE 2-10.—Retrorocket fire schematic diagram.

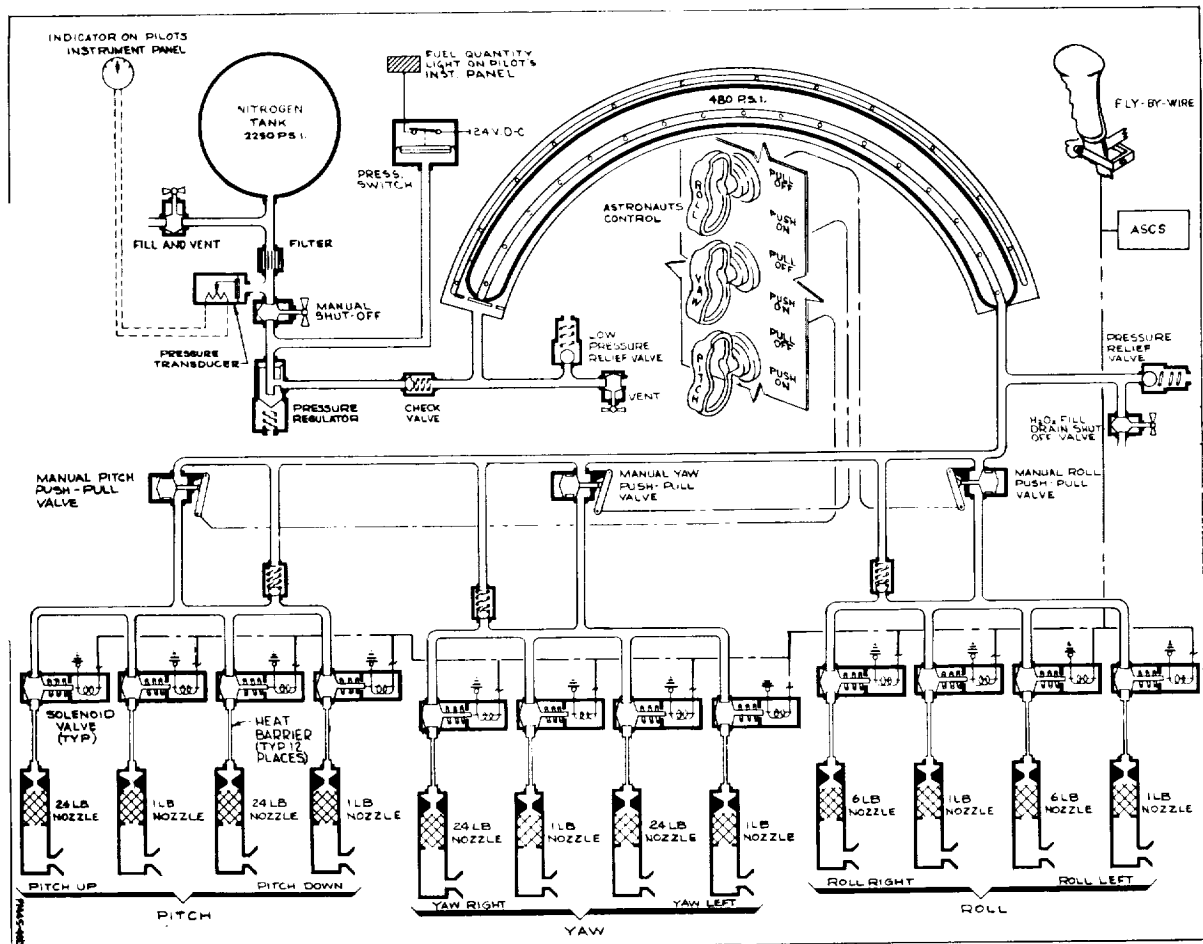
(a) System A.

FIGURE 2-12.—Reaction control system schematic diagrams.

The thruster impulse is directed by the four basic control modes through 18 individual system, as shown in figure 2-11. Figures 2-12(a) and 2-12(b) show the A and B systems RCS schematic diagrams. Figures 2-12(a) and 2-12(b) do not show completely the methods of electrically controlling the thrusters; in figure 2-12(a) there is a switch missing between the hand controller and the ASCS control box which permits selection of either FBW or ASCS. Similarly, in figure 2-12(b) the connection of the hand controller through a switch and the ASCS control box to the thruster solenoids for RSCS control is missing. Metered quantities of hydrogen peroxide are decomposed in silver-plated catalyst beds in each of the thruster chambers to provide the desired impulse. Twelve of the thrusters used on the Mercury spacecraft are sized to provide adequate control during the retromaneuver.

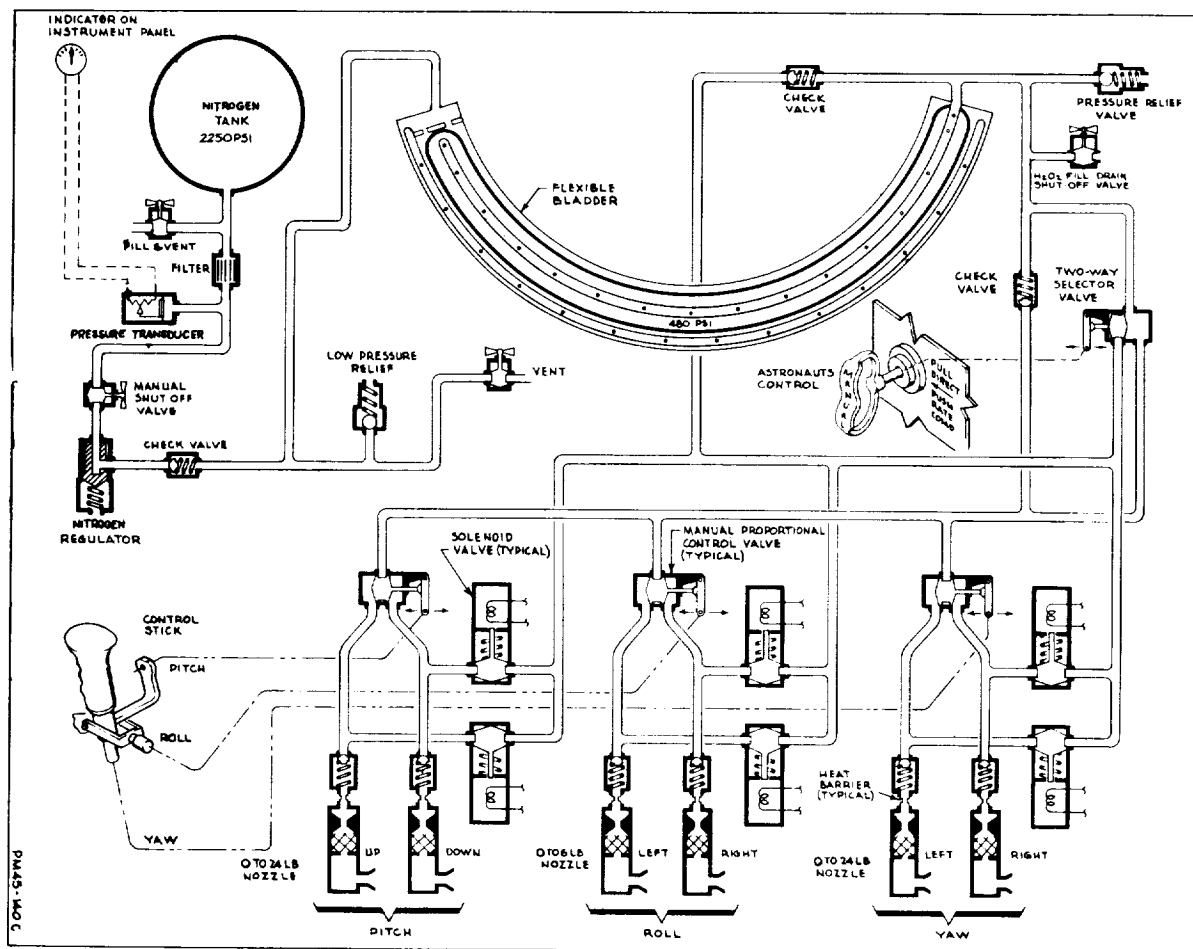
(b) System B.

FIGURE 2-12.—Concluded.

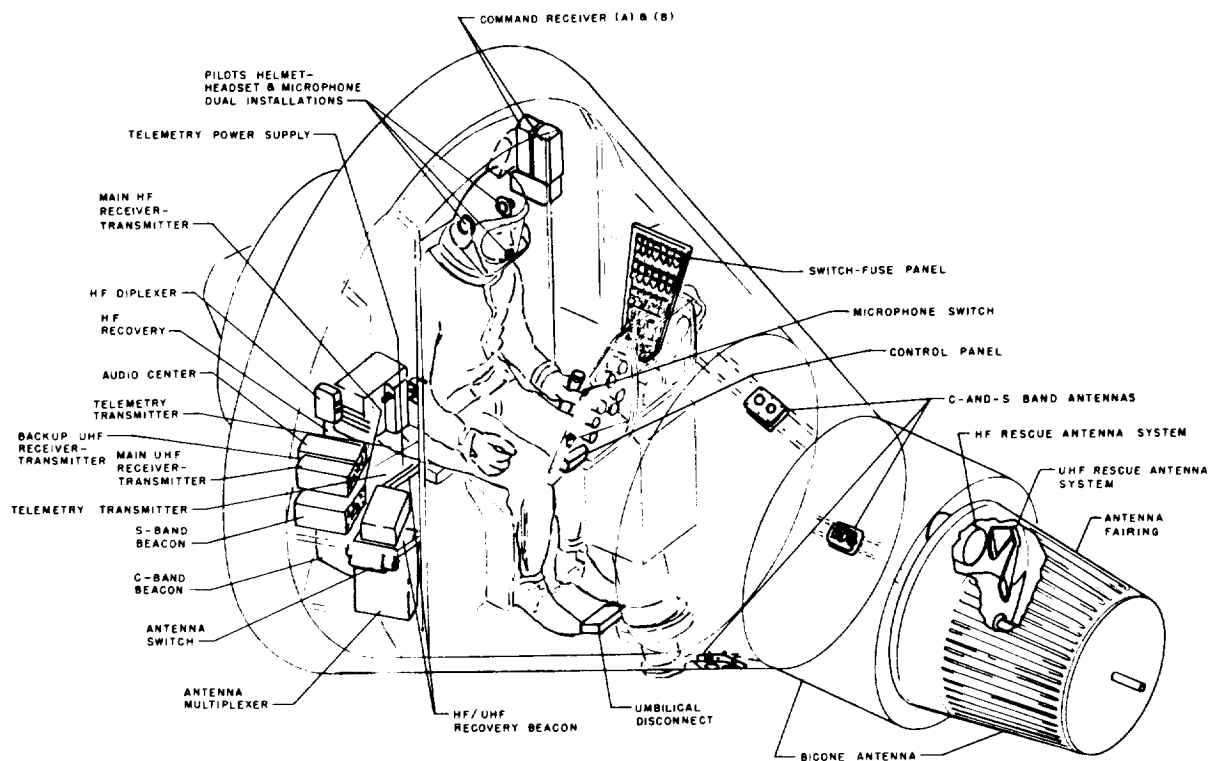
The spacecraft communications and instrumentation systems consisted of voice, radar, command, recovery, and telemetry links. Each system had main and backup (or parallel) equipment for redundancy, with selection of the desired system generally at discretion of the astronaut through switches mounted on the instrument panel. Table 2-II is a list of the systems, and figure 2-13 shows the physical lo-

FIGURE 2-13.—Locations of major components of communications system.

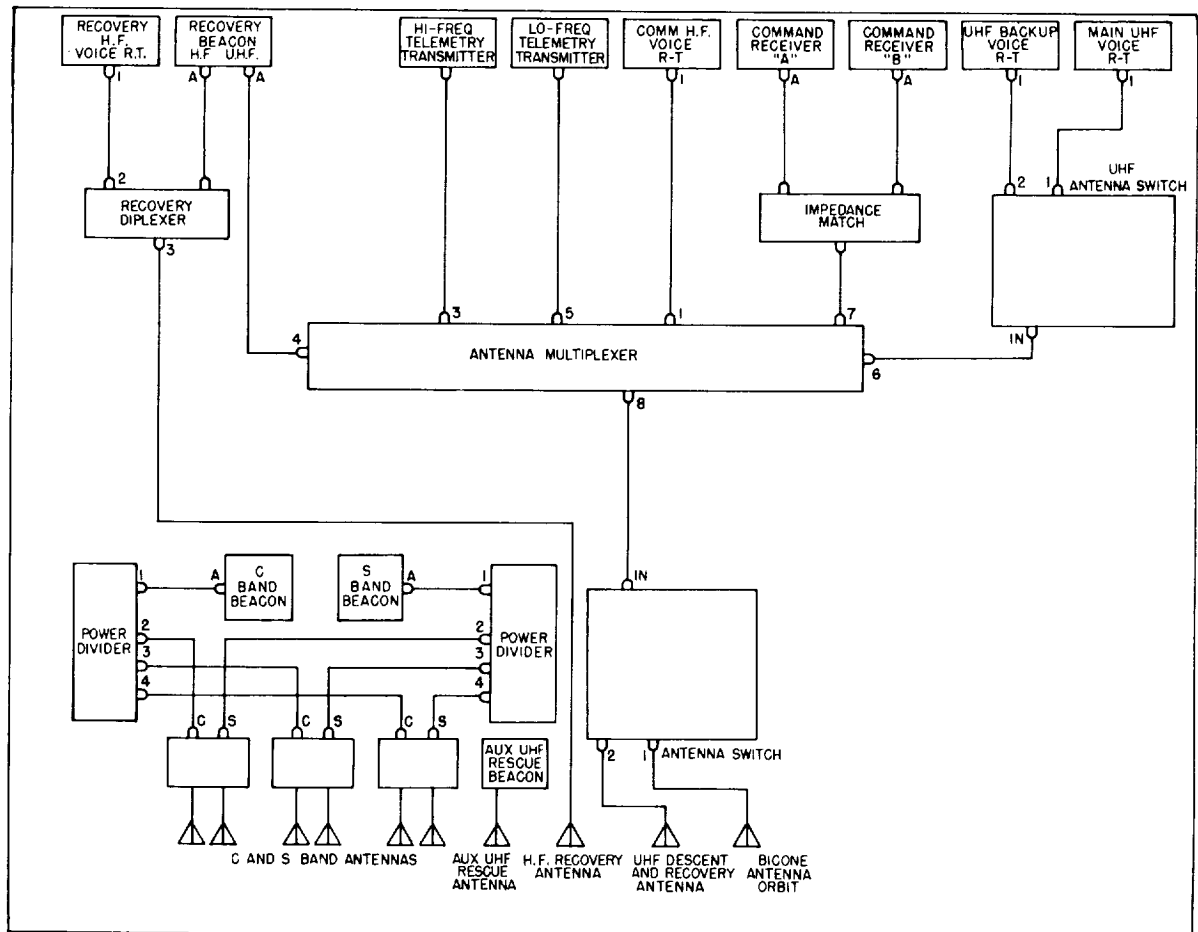
FIGURE 2-15.—Communications and antenna systems schematic diagram.

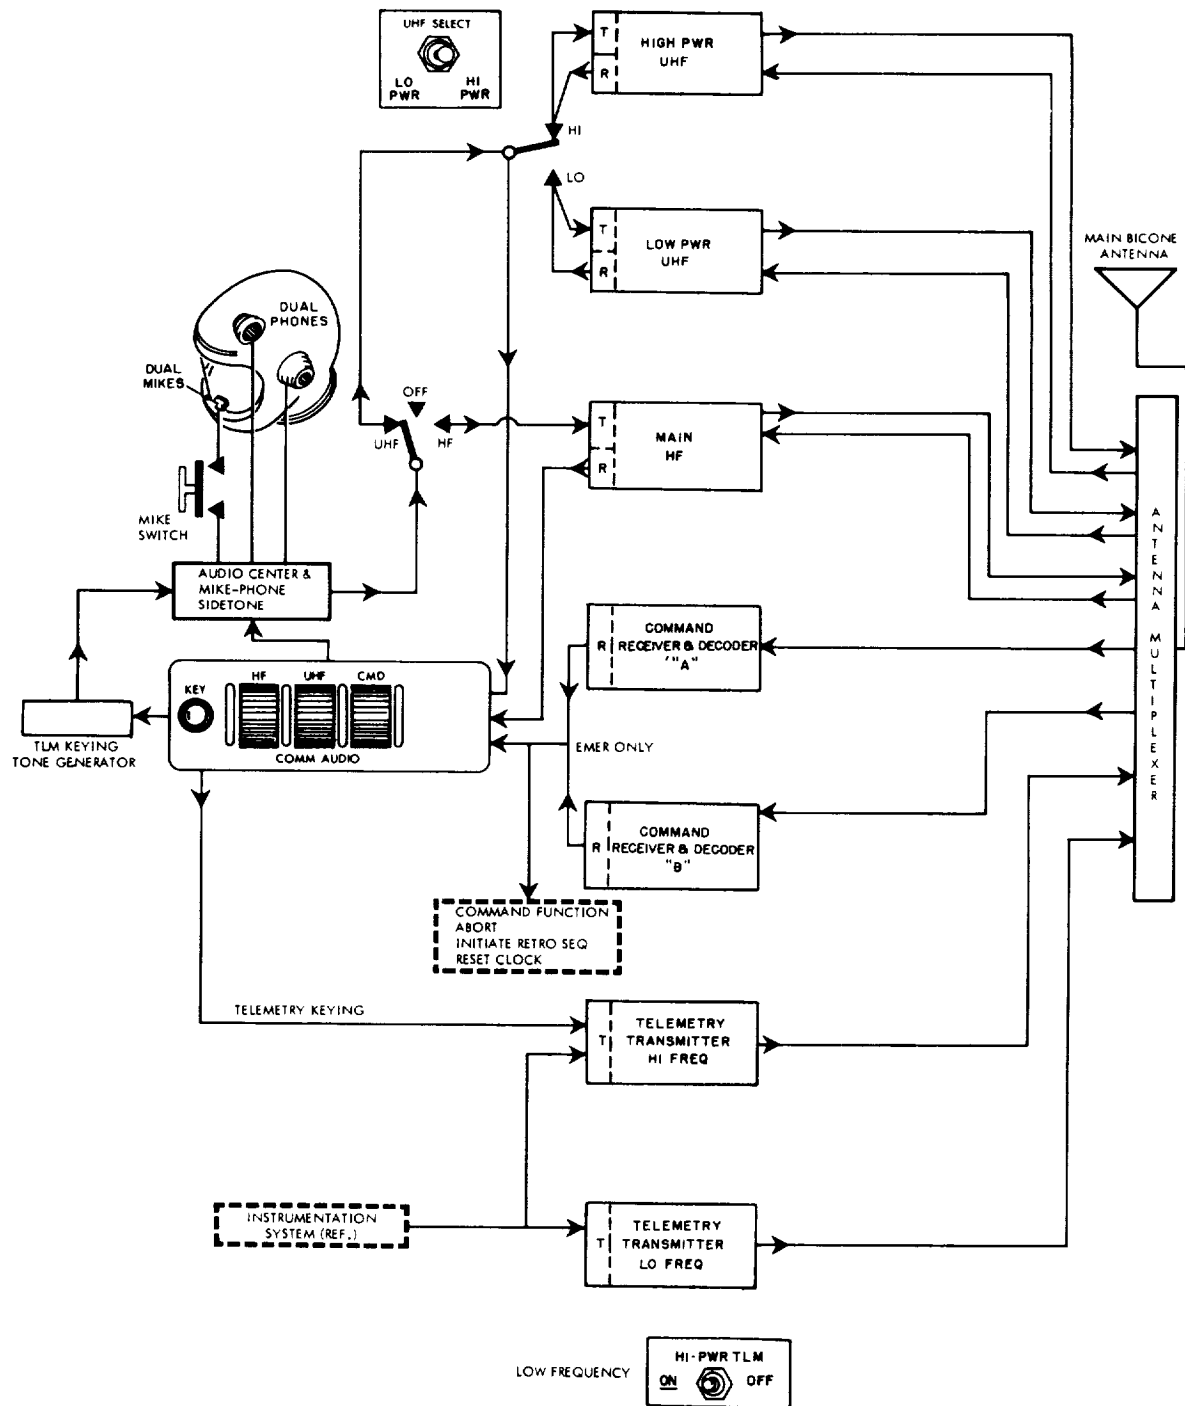
FIGURE 2-16.—Voice systems schematic diagram.

perience and ground tests, it was known that the IIF system had somewhat poorer voice fidelity but longer range than the UHF system. The UHF system, because of its slightly better voice quality, was considered to be the primary system. From previous experience, it was known that the range of the UHF system was approximately equal to the line-of-sight range and was entirely adequate for a normal mission. The main voice traffic was therefore conducted on the UHF system, with a small amount of traffic conducted on the HF system to verify system operation. It might be noted that the UHF system consisted of a main and a backup transmitter-receiver. Thus, three separate voice systems were available for choice of the astronaut—HF, UHF main, and UHF backup—as shown in figure 2-16. Also, a redundant ground-to-air voice link is available through the command receiver channel. An additional air-to-ground communication link is available to the astronaut by keying the low-frequency telemeter carrier. It should be noted that all of these links use the main bicone antenna through the use of a multiplexer.

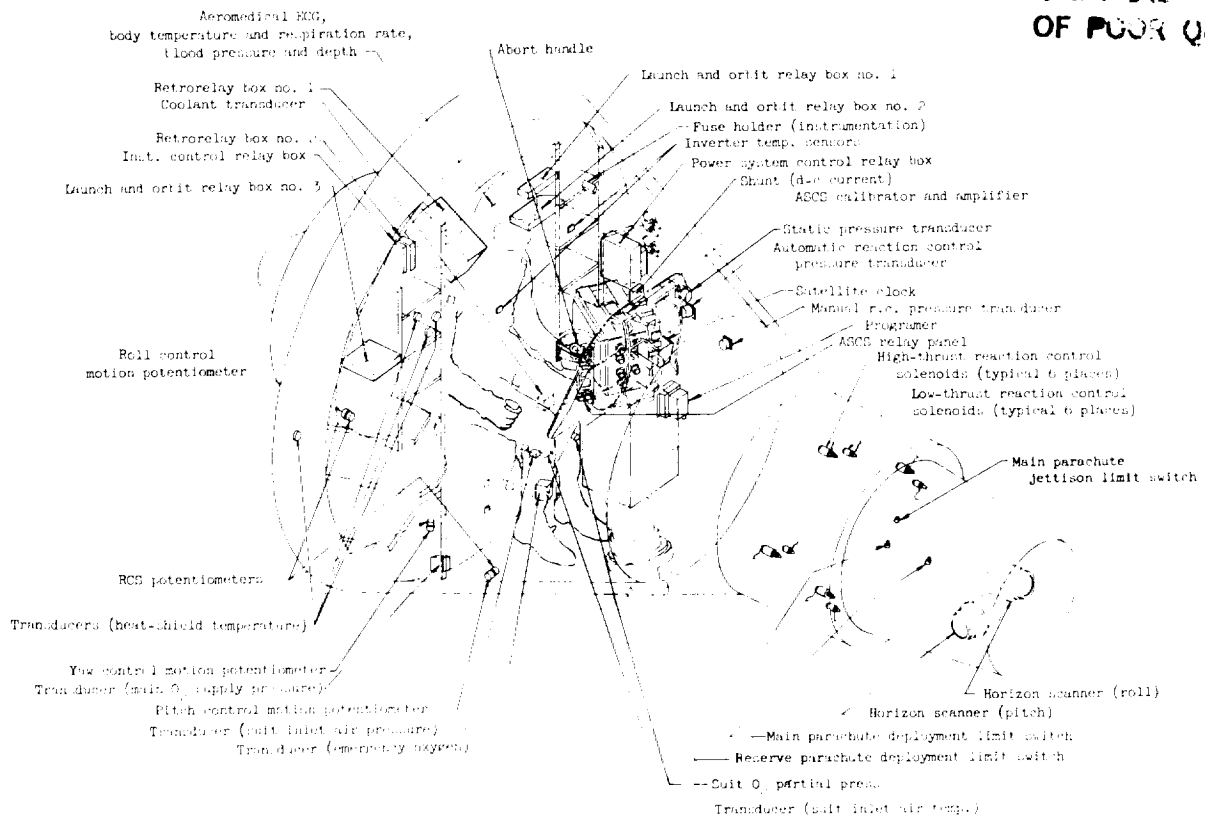
FIGURE 2-17.—Location of some spacecraft instrumentation sensors.

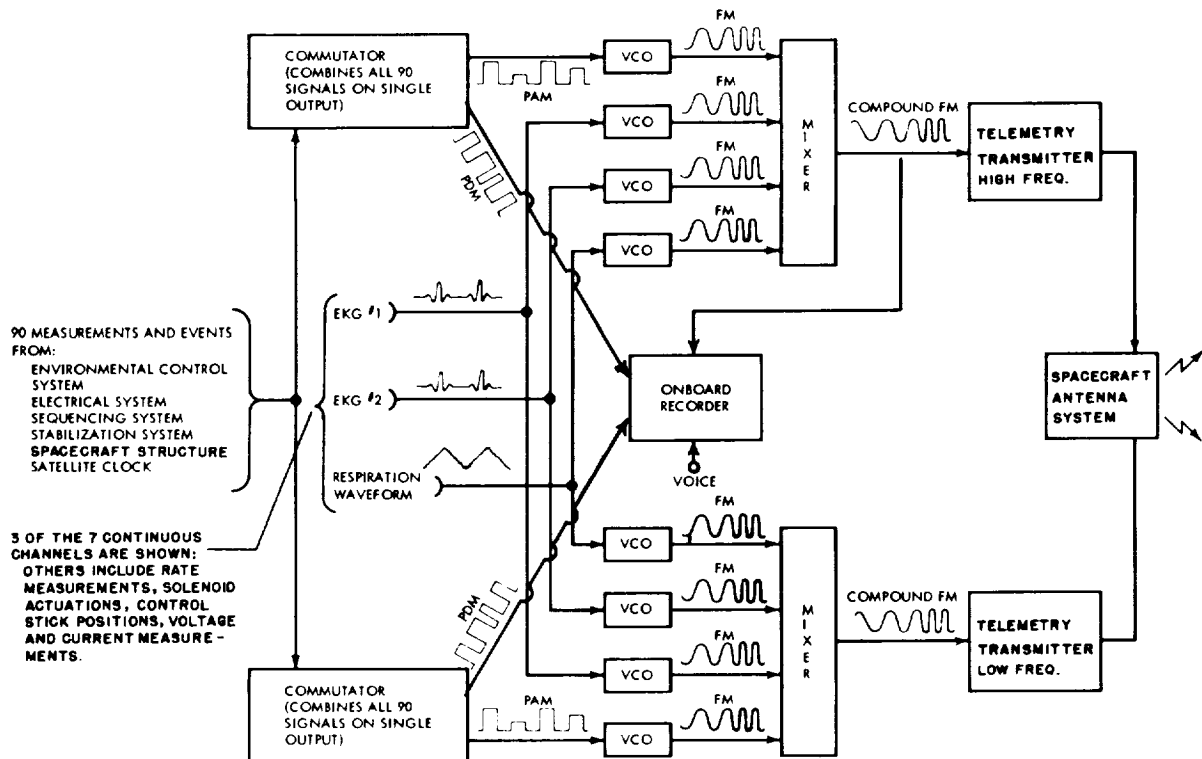
FIGURE 2-18.—Instrumentation system schematic diagram.

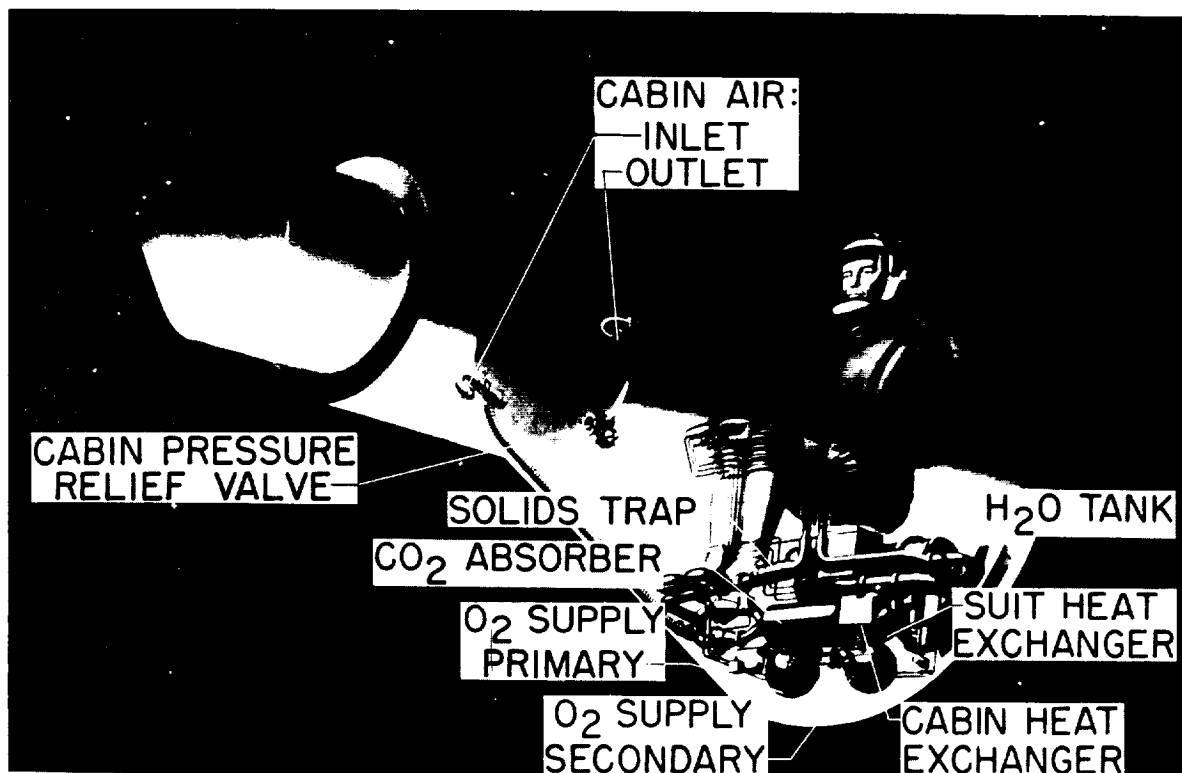
FIGURE 2-19.—Approximate physical arrangement of spacecraft environmental control system.

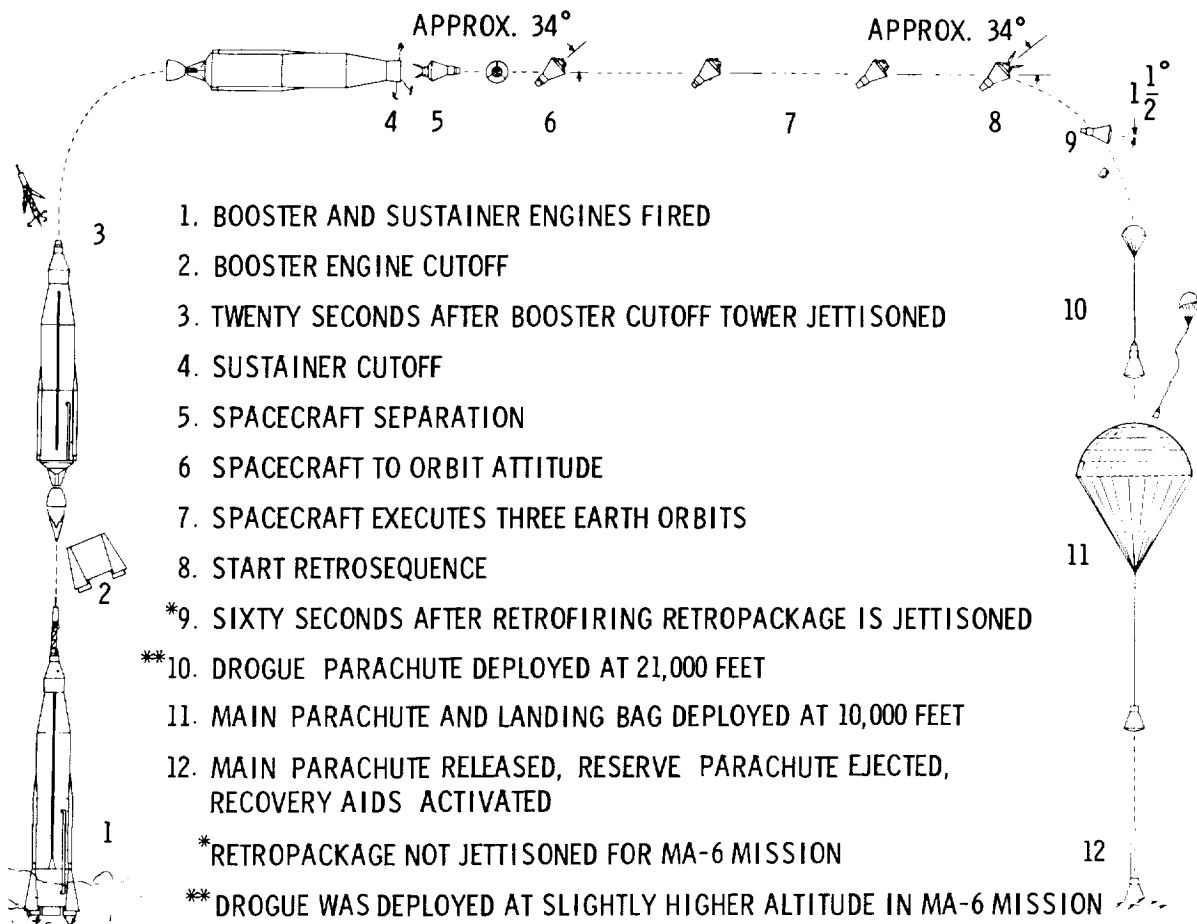
FIGURE 2-22.—Sequence of major events for the MA-6 mission.

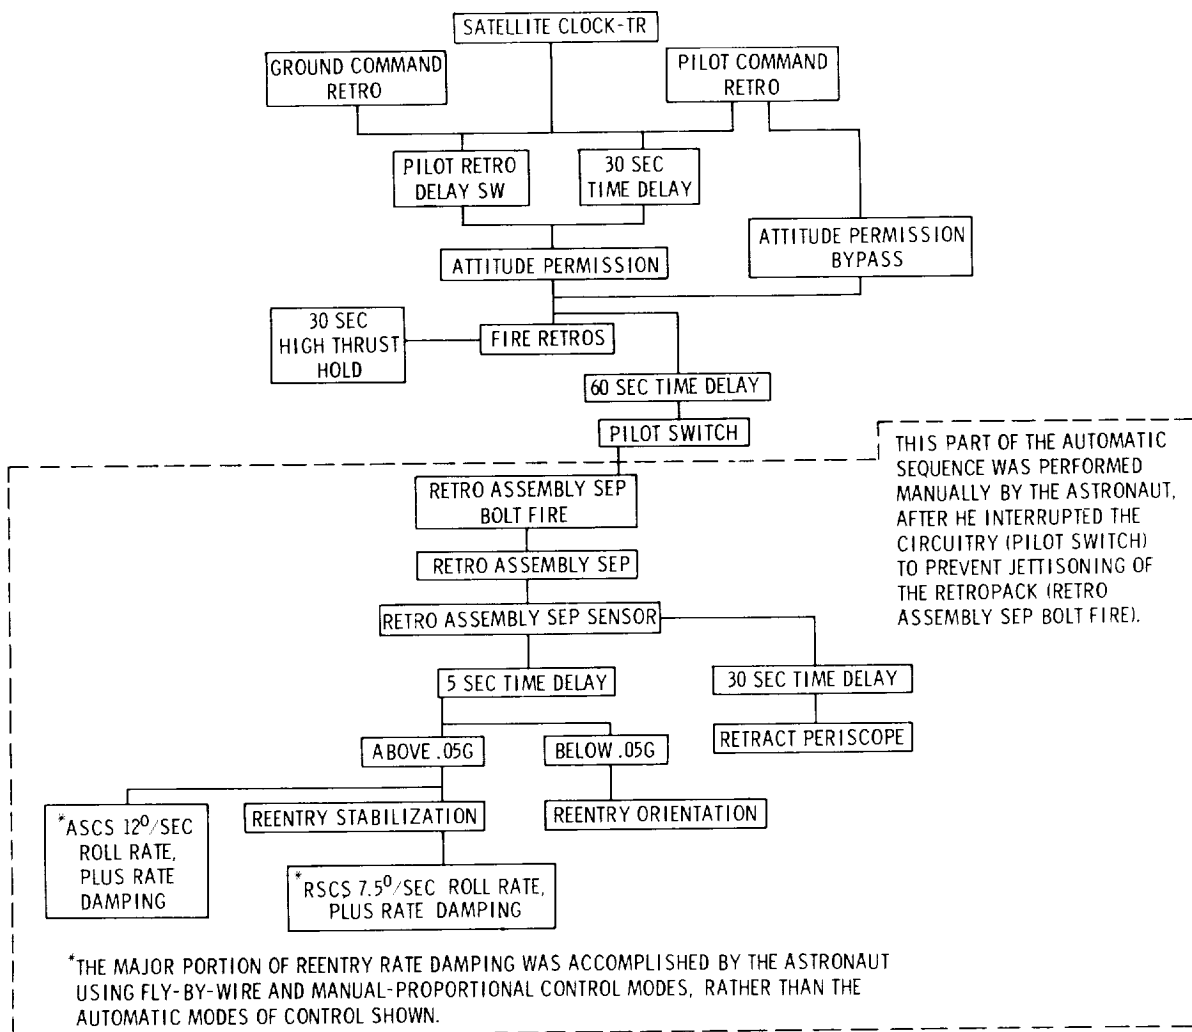
(b) Retrograde and reentry.

FIGURE 2-23.—Continued.

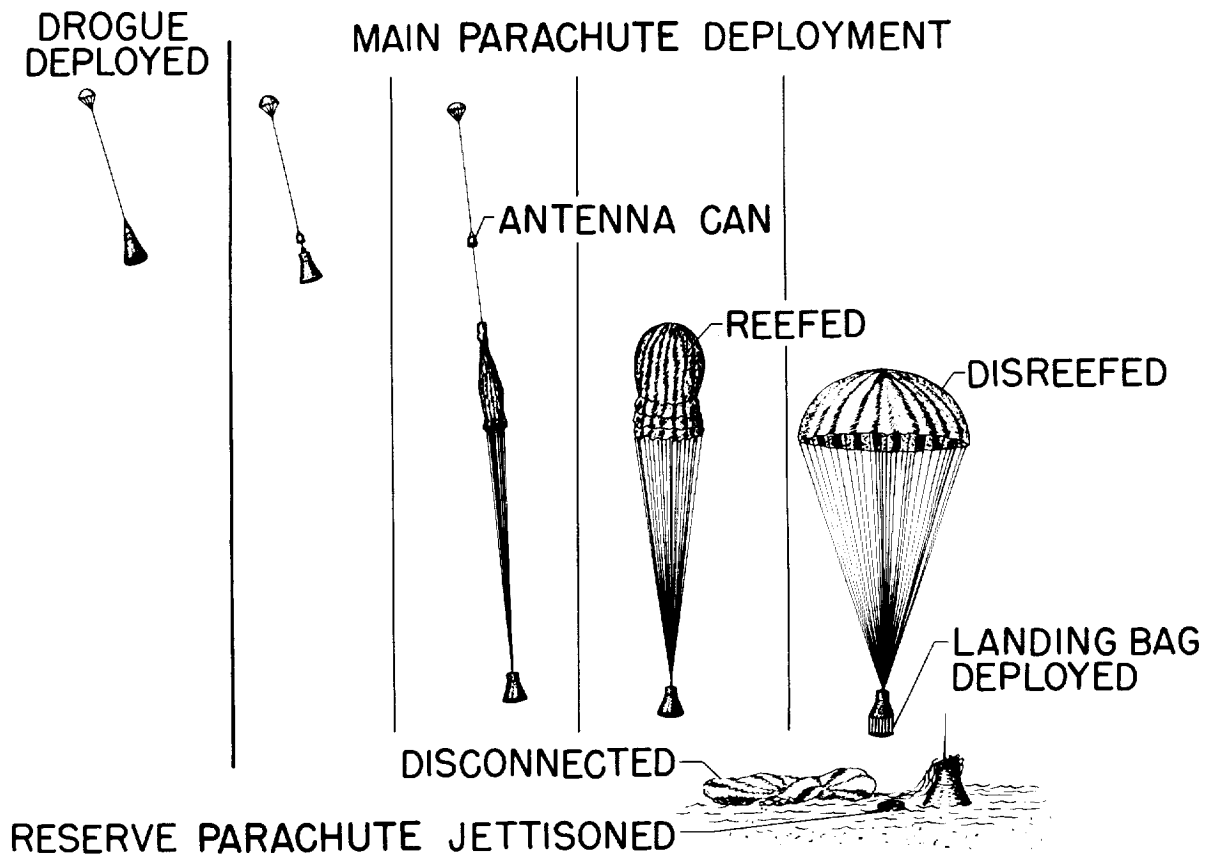
The landing system is normally actuated at an altitude of about 21,000 feet by either one of two barostats which sense atmospheric pres-

sure. At this time, the drogue parachute is deployed to decelerate and stabilize the spacecraft. At about 10,000 feet, the antenna section and drogue parachute are jettisoned by the signals from another dual barostat and the main parachute is deployed in a reefed condition opened to 12-percent of the maximum diameter for 4 seconds to minimize the opening shock. The main parachute deploys fully after 4 seconds of reefing. A reserve parachute may be deployed by the astronaut in the event the main parachute is unsatisfactory. After main parachute deployment, the landing bag is extended to provide attenuation of the landing load. Immediately after landing, the main parachute is automatically disconnected and the reserve parachute is ejected.

FIGURE 2-24.—Sketch depicting use of spacecraft landing systems.

The drogue parachute deployed at an acceptable but somewhat higher than expected altitude during the MA-6 mission. Both drogue and main parachutes were observed by the astronaut to be in good condition after deployment. The heat shield released properly and the landing bag attenuated the landing loads about as expected.

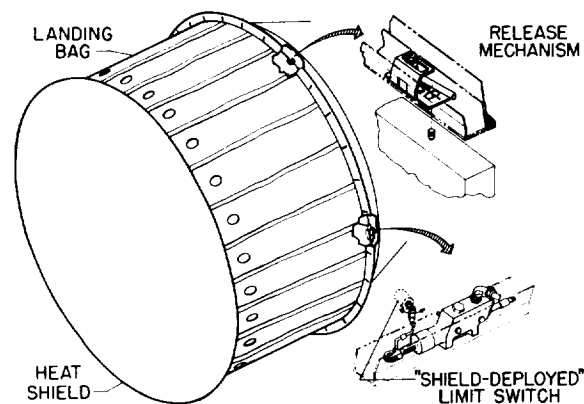
The "heat-shield-deployed" signal, that is sent to the telemetry system, is furnished by either one of two limit switches which sense the movement of the heat-shield retention devices as shown in figure 2-25. During the orbital flight portion of the MA-6 mission, one of these switches sent a "shield-deployed" signal to the ground monitoring stations. Post-

FIGURE 2-25.—Details of heat-shield deployment mechanism and sensing switches.

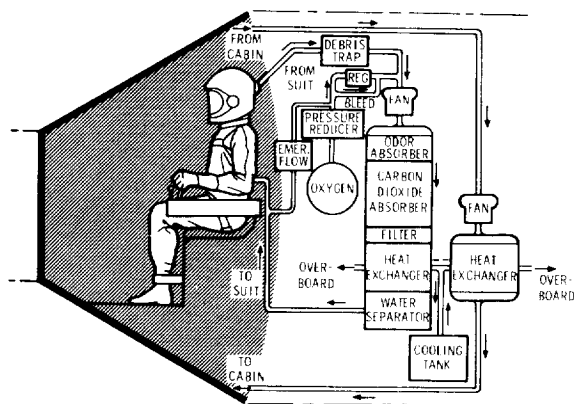
The pressures in the cabin and pressure suit are maintained at 5.1 psia in normal flight with a 100-percent oxygen atmosphere. The system is designed to control automatically the environmental conditions within the suit and cabin throughout the flight. Manual controls are provided to enable system operation in the event of automatic control malfunction. In describing the environmental control system, it can be considered as two subsystems; the pressure-suit control system and the cabin system. Both of these systems operate simultaneously from common coolant water and electrical supplies. The coolant water is stored in a tank with a pressurized bladder system to facilitate weightless flow of water into the heat exchanger. Electrical power is supplied from an onboard battery supply. Oxygen is supplied at an initial

FIGURE 3-2.—Schematic diagram of the Mercury environmental control system.

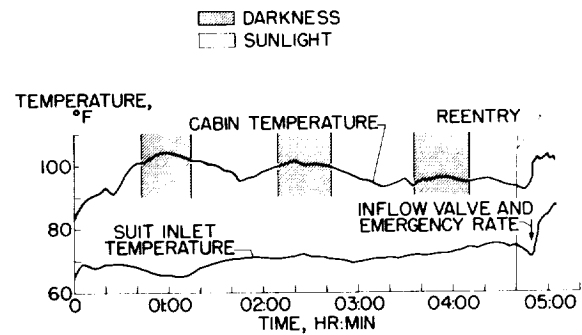
The cabin air temperature (fig. 3-3) fluctuated between 90° F and 104° F as the spacecraft passed from darkness into sunlight. The astronaut reported that at least five attempts to reduce cabin air temperature by increasing water flow to the cabin heat exchanger resulted in the illumination of the excess-water light. This light indicated that the cabin heat ex-

FIGURE 3-3.—Variation of suit and cabin temperatures with time.

changer was operating near its maximum capacity for the existing conditions. Even so, the mean cabin air temperature was steadily reduced during the mission after the first hour in orbit.

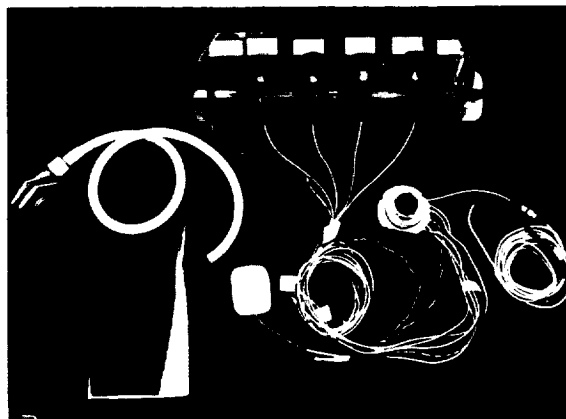
The ECG sensors consist of rings composed of silicone rubber. The rings are constructed

FIGURE 3-15.—Flight sensor harness.

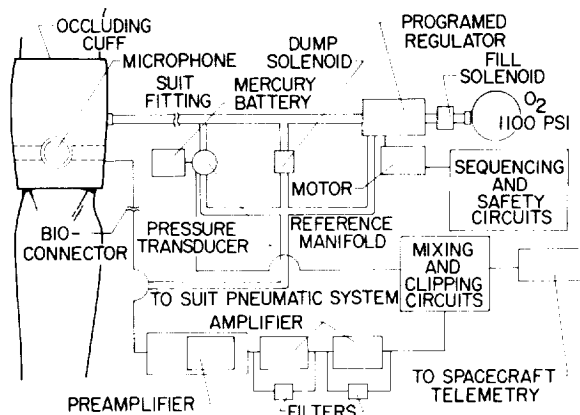
The original concept of the BPMS (fig. 3-16) was an automatic system, which would be initiated from a tracking station through the command receiver, by an automatic sequencing device onboard or by the pilot. The automatic system incorporated special safety circuits to dump the cuff pressure if the cuff stayed above

FIGURE 3-16.—Block diagram of automatic BPMS.

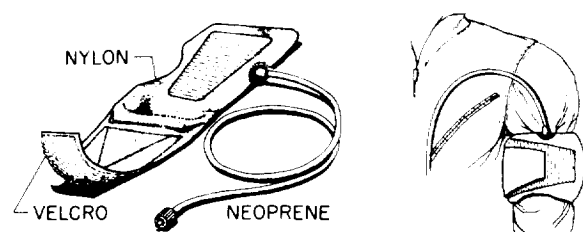
During the testing of the preliminary system on astronauts and other flight personnel it became evident that the standard 5-inch clinical cuff was unsatisfactory because of its stiffness, bulk, and the fact that arm movement was restricted. A new cuff (fig. 3-17) was devised by

FIGURE 3-17.—BPMS cuff.

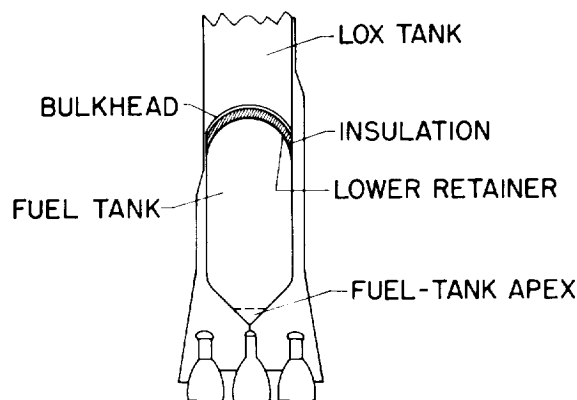
After electrical mating, the launch vehicle and spacecraft participate jointly in all tests. These tests are discussed in paper 5 on spacecraft preparation. The first attempt to launch MA-6 was on January 27, 1962. The launch vehicle was loaded with fuel on January 24. However, the mission was canceled because of excessive cloud cover in the launch area and was rescheduled for February 1; so the fuel tank was drained. On January 30, the fuel tank was again loaded; however, normal inspection procedures disclosed that the insulation-retaining bulkhead in the fuel tanks was leaking. Figure 4-14 shows a sketch of this bulkhead.

FIGURE 4-14.—Bulkhead between fuel and liquid oxygen tanks.

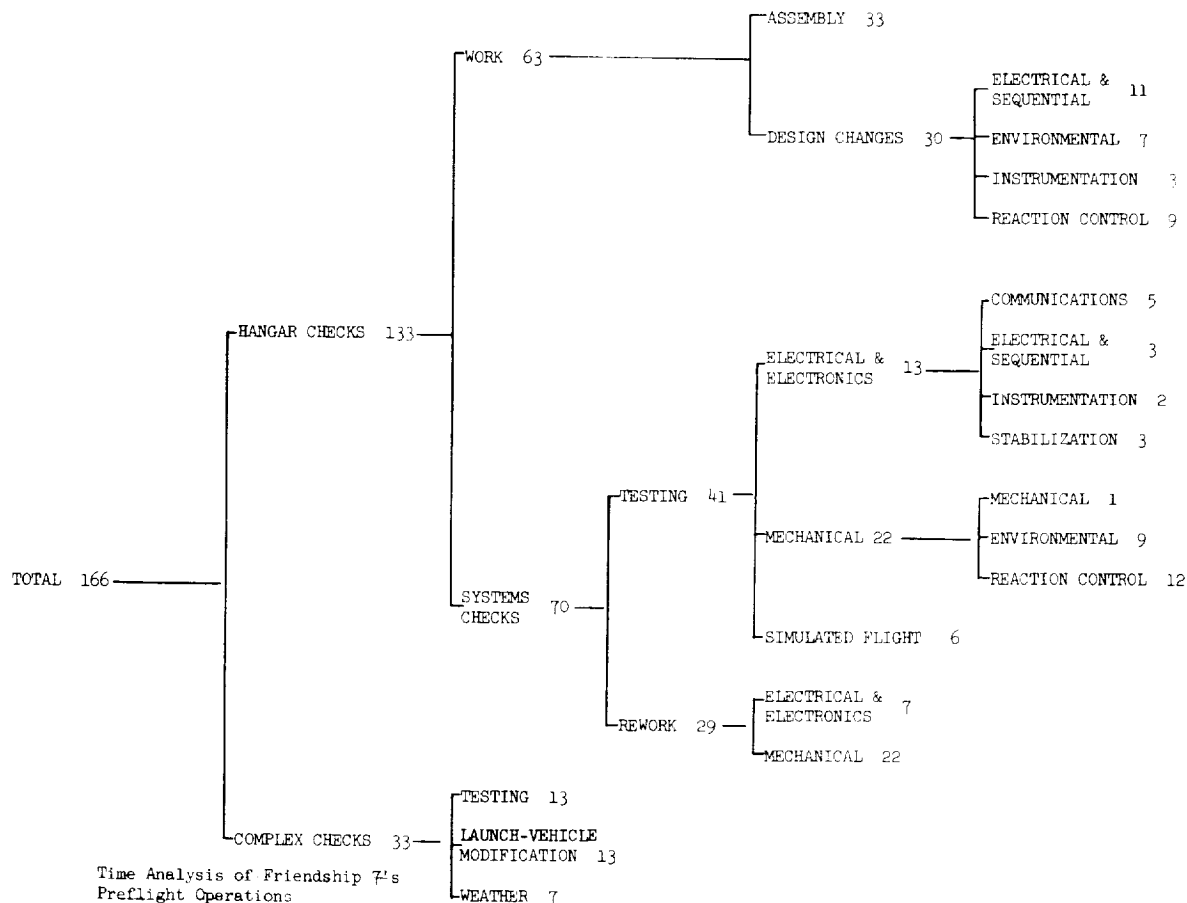
FIGURE 5-1.—Time analysis of preflight operations on Friendship 7.

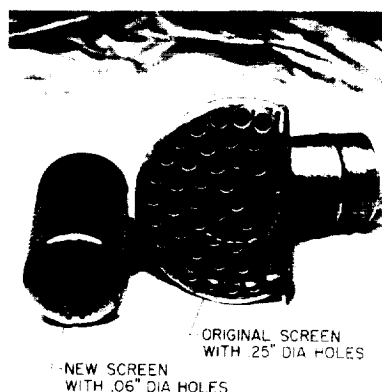
FIGURE 5-5.—Cooling fan duct inlet screens for Friendship 7 and Spacecraft 9.

(2) The cooling fan duct inlet screens were changed to screens having 0.06-inch diameter holes. (See figure 5-5.) This change was required when the postflight inspection of spacecraft 9 revealed that the cabin fan was jammed by small bits of metal, fabric, and rubber, shown in figure 5-6, which were ingested into the fan under zero-g conditions through the 0.25-inch diameter holes in the inverter cooling duct screens.

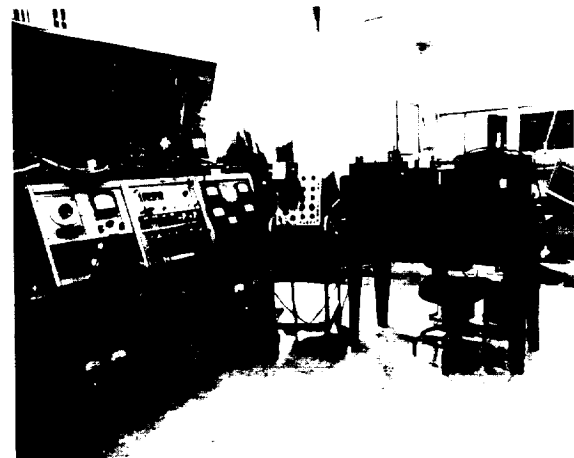
The instrumentation system was thoroughly tested and calibrated on the bench as shown in figure 5-8 at Cape Canaveral prior to its installation in the spacecraft. The system was tested again after it had been installed in the spacecraft. The primary purpose of the latter test is fourfold: (1) to determine the error, if any, between the hardline signal normally used to transmit data to the blockhouse or other test equipment in the hangar and the signal radiated through the transmitter; (2) to determine possible system interference with the system operating in the spacecraft; (3) to make a sin-

FIGURE 5-8.—Bench setup for testing spacecraft instrumentation.

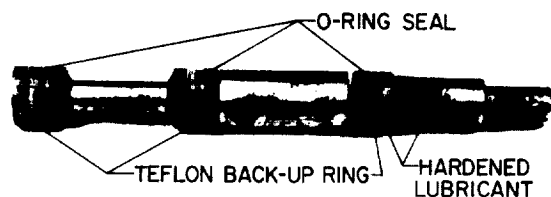
(1) Excessive leakage of the high-pressure oxygen shutoff valve was noted. The stem was removed from the valve body and the lubricant was found to have hardened on the O rings and sealing surfaces (fig. 5-9). The O rings and backup seals were replaced, and the component was lubricated and replaced in the valve body. The valve continued to show a leakage caused by the seals not seating properly. The

FIGURE 5-9.—High-pressure shutoff oxygen valve stem shown with hardened lubricant.

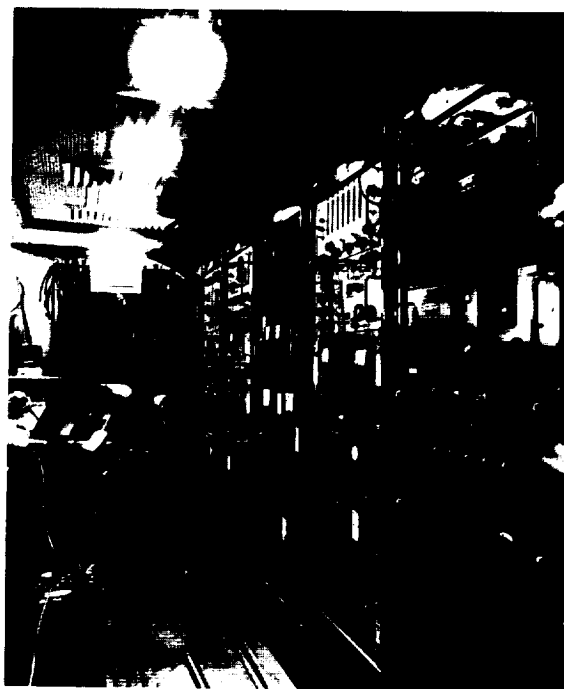
The primary purpose of the communication system tests was to determine the electrical characteristics of the individual components that comprise the onboard communications system. Although the test equipment was physically located approximately 100 feet away in the checkout trailer (fig. 5-10), the test was

FIGURE 5-10.—Communications system test equipment in checkout trailer.

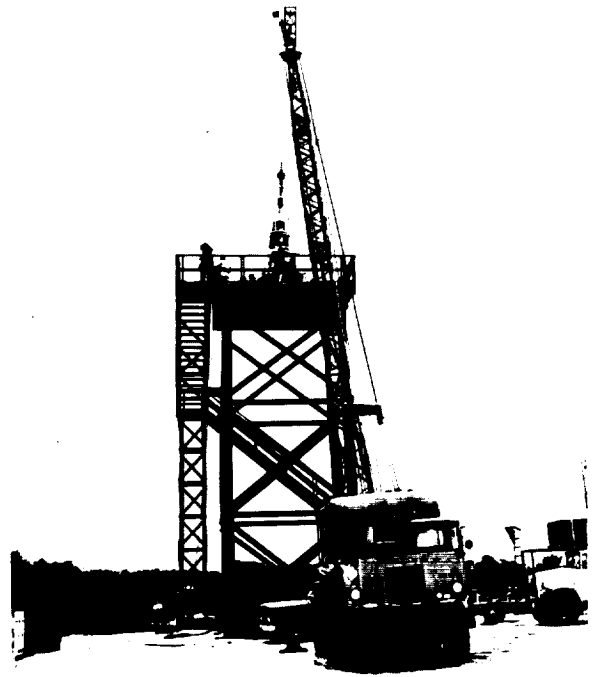
FIGURE 5-12.—Spacecraft being installed on communications tower for communication antenna tests.

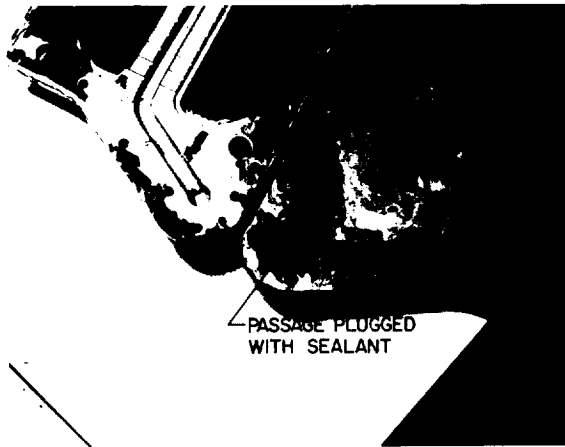
verter remained cool. A subsequent investigation indicated that the flow passages in the water-type heat exchanger (cooling plate) were plugged. It was found that sealant used in the construction of the cooling plates had penetrated into the flow passages as shown in figure 5-16. The passages were cleaned and the original orifices were reinstalled. Flow tests on the final installation showed that the system was clean.

FIGURE 5-16.—Plugged inlet part of cooling plate for 150 v-amp inverter.
