**RESULTS OF THE
FIRST UNITED STATES
MANNED ORBITAL SPACE FLIGHT
FEBRUARY 20, 1962**

NATIONAL AERONAUTICS AND SPACE ADMINISTRATION

**MANNED SPACECRAFT CENTER
NATIONAL AERONAUTICS
AND SPACE ADMINISTRATION**

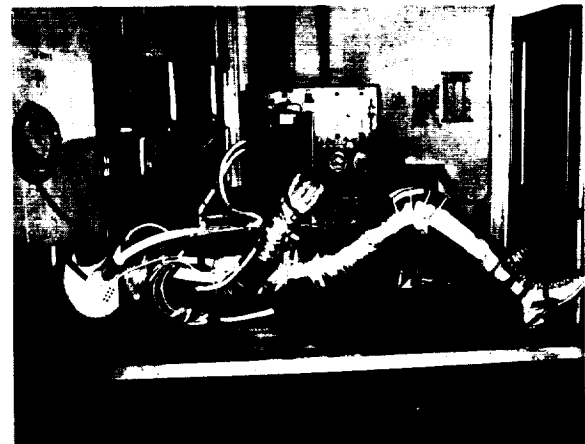
Prior to and after astronaut donning of the pressure suit the complete assembly was pressurized and leak checked at 5 psig, and at 5 inches of water differential pressure. This test console provides the pressure control and leakage measurement system required.

FIGURE 5-25.—Pressure tests of astronaut's pressure suit at 5 psi.

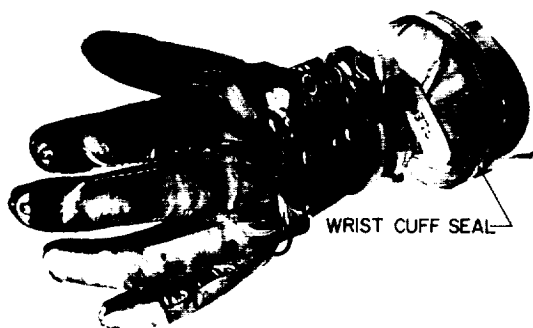
FIGURE 5-27.—Pressure-suit gloves showing cuff slip joint.

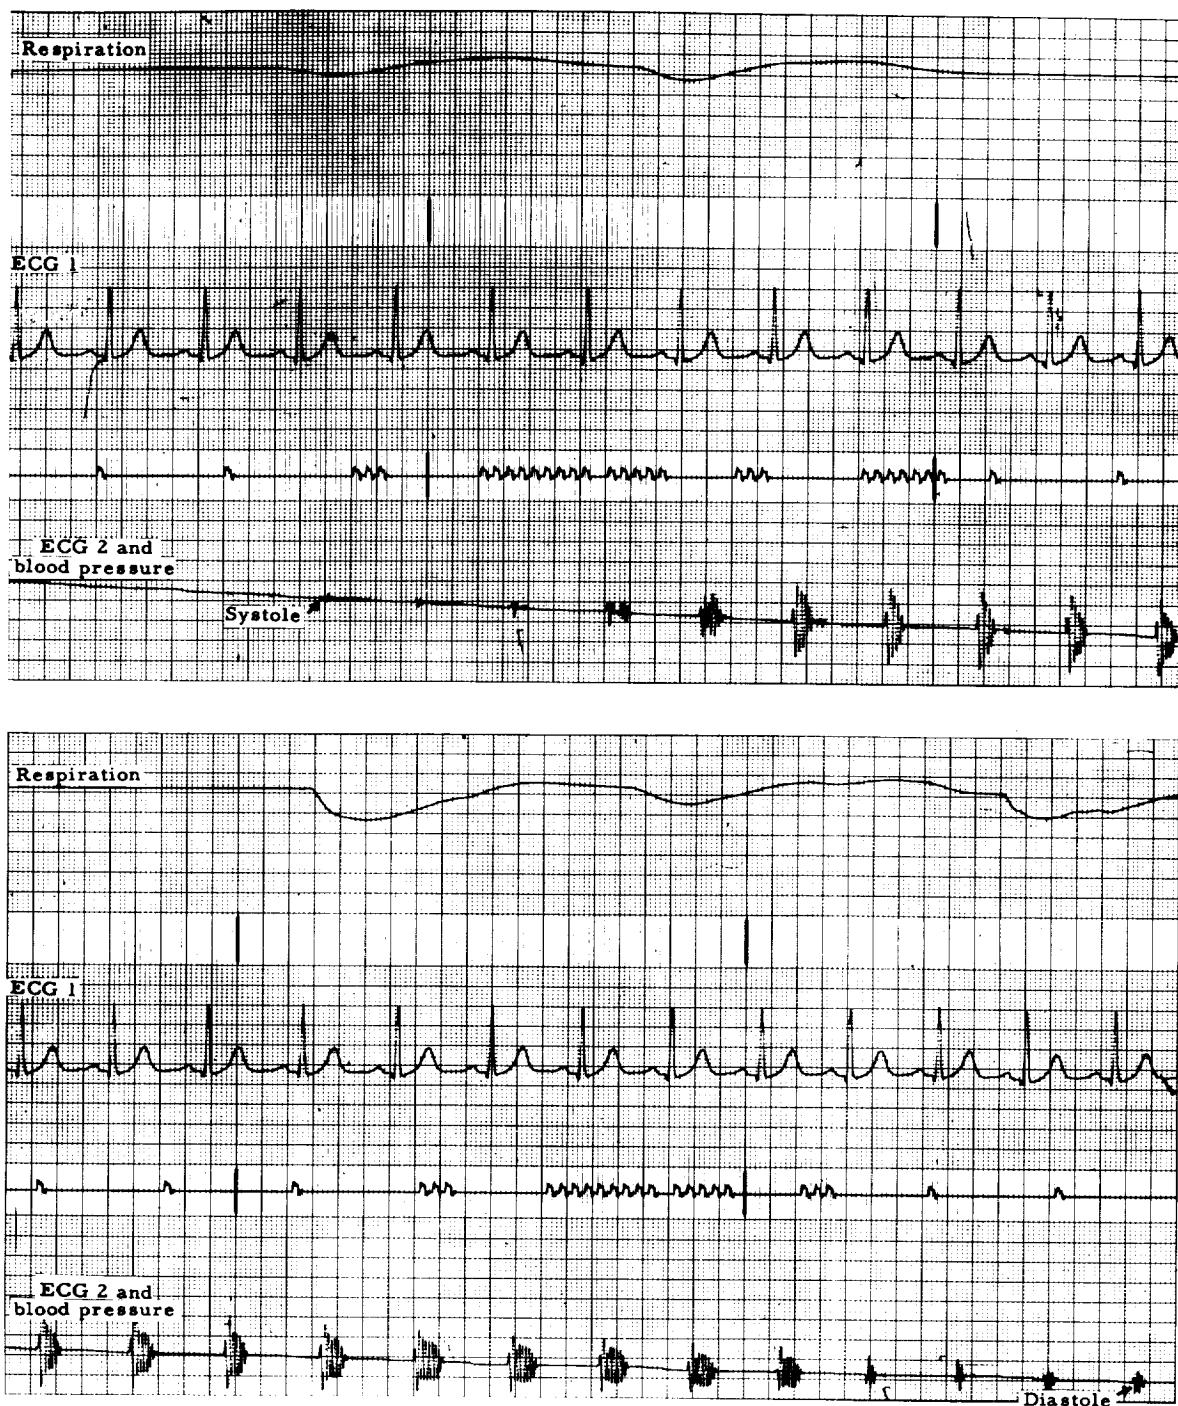
FIGURE 9-8.—Sample of physiological record received at the Hawaii Range Station corresponding to figure 9-7. (Recorder speed 25 mm/sec).

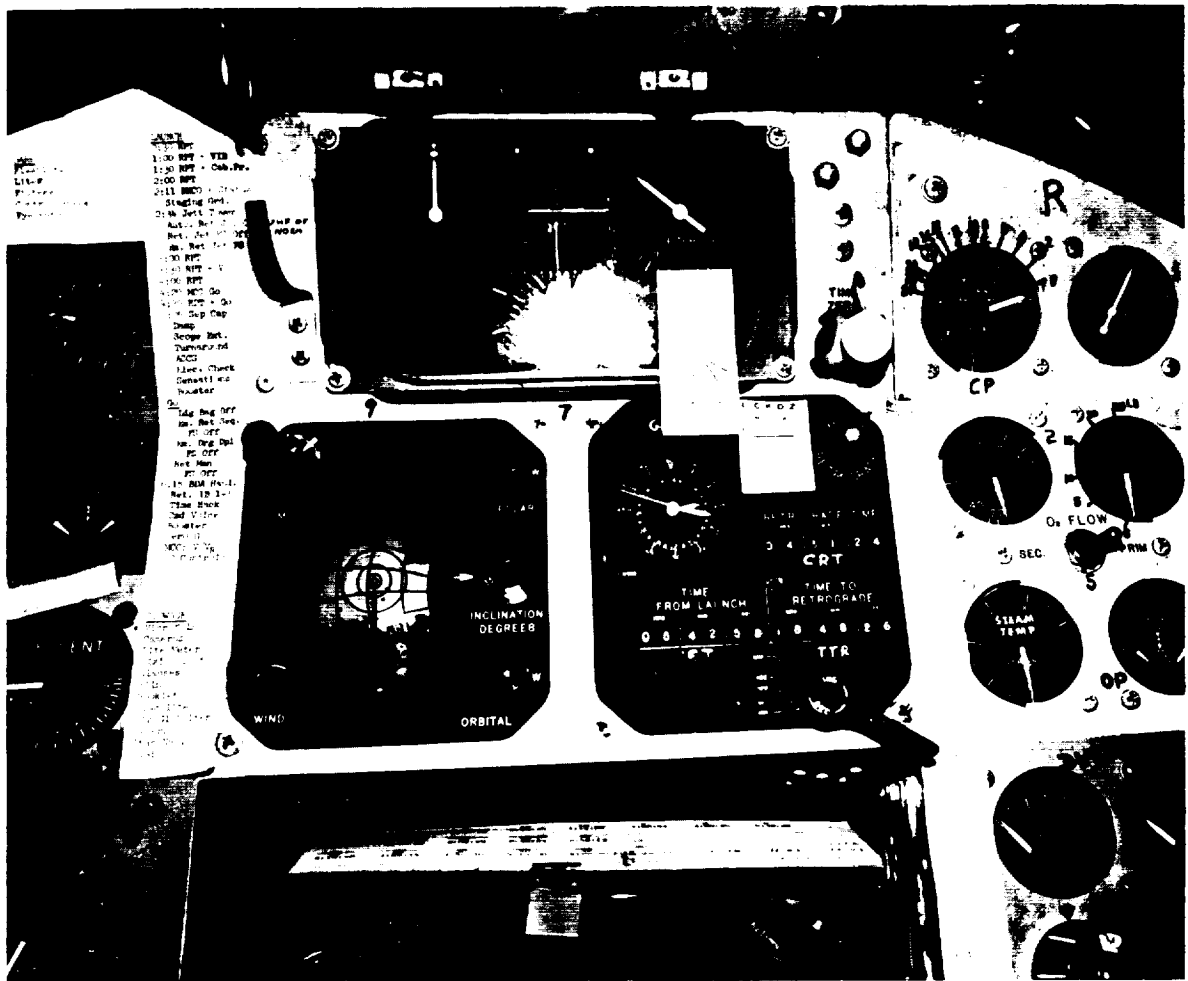
FIGURE 11-2.—MA-6 instrument panel, center section.

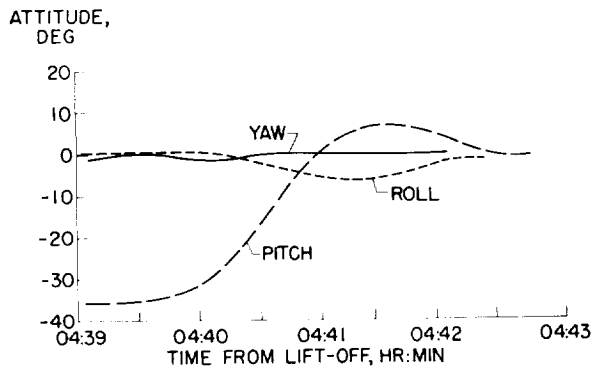
FIGURE 11-5.—MA-6 reentry pitch maneuver.
