NATIONAL AERONAUTICS AND SPACE ADMINISTRATION
MANNED SPACECRAFT CENTER • HOUSTON, TEXAS

GEMINI PROGRAM MISSION REPORT

GEMINI 2

MSC-G-R-65-1

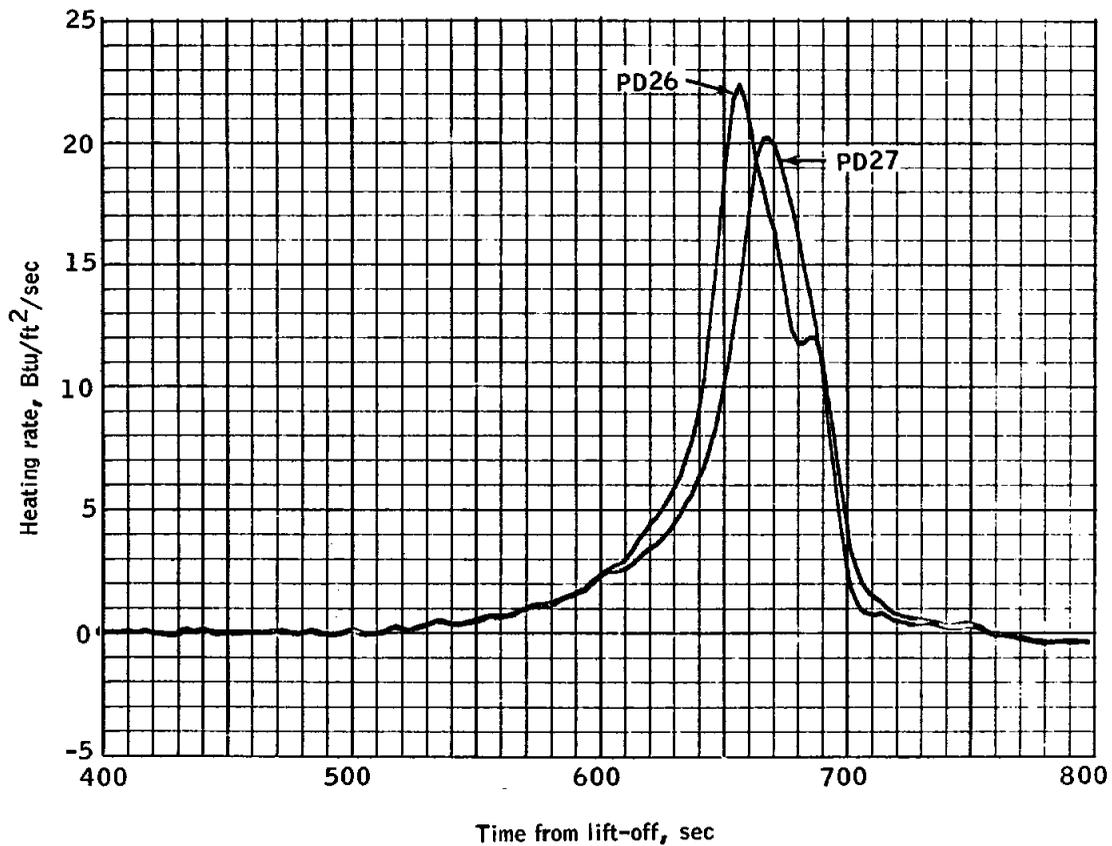
(b) Localized heating in wake of windward adapter interconnect fairing

Figure 5.1-6. - Continued

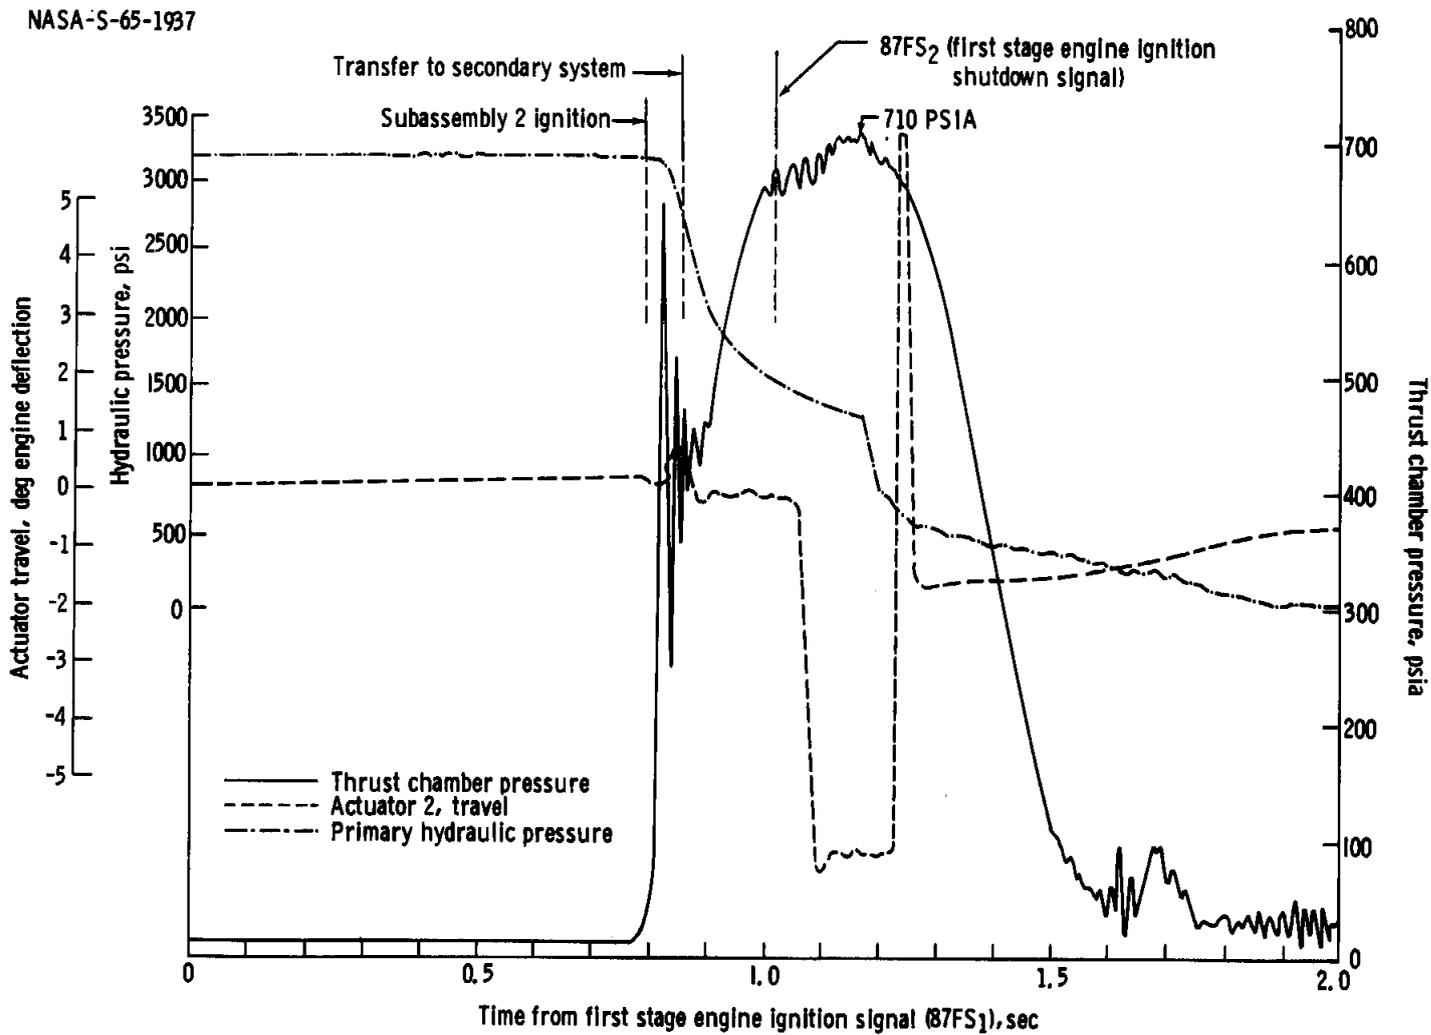
Table 13-I lists a chronology of events during the period from engine command (87FS1) to shutdown command (87FS2). Figure 13-1 is a time history of pertinent parameters during the start and shutdown period. In this figure the near coincidence of the ignition spike with the beginning of the drop in hydraulic pressure can be seen. Also shown is the observed motion of the 2₁ actuator. A data review indicated an erroneous hardover in one direction (retract) and then a hardover in the opposite direction (extend) as shown. This was later proved to be a malfunction of the position transducer.

Figure 13-1. - GLV start transient

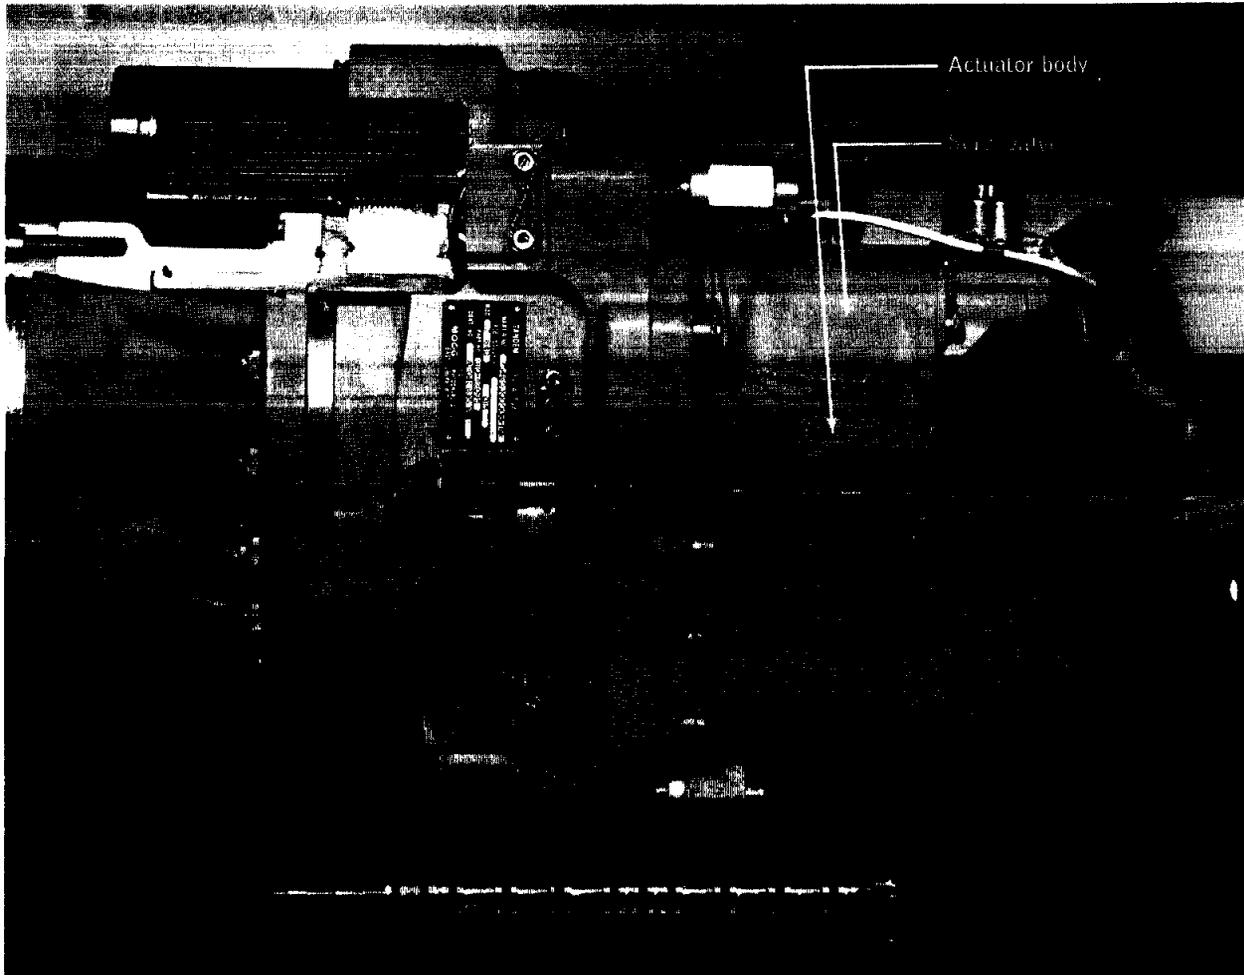
At this point disassembly of the actuator was begun. After removing the tailstock, it was found that both mounting feet on the torque motor end of the servovalve body had been fractured (see fig. 13-2) and the actuator-servovalve interface O-rings extruded from the grooves. Figure 13-3 shows a typical actuator with part of the case removed to reveal the assembly to a servovalve on the body of the actuator. Figure 13-3 shows the failed servovalve body and the fractures of the mounting lug. Note that one fracture passed through a small drilled hole; this hole (port) was for bench checking purposes. The larger ports with O-ring grooves are those for pressure supply, return, extend, and retract.

Figure 13-3. -GLV Tandem actuator with part of the case removed

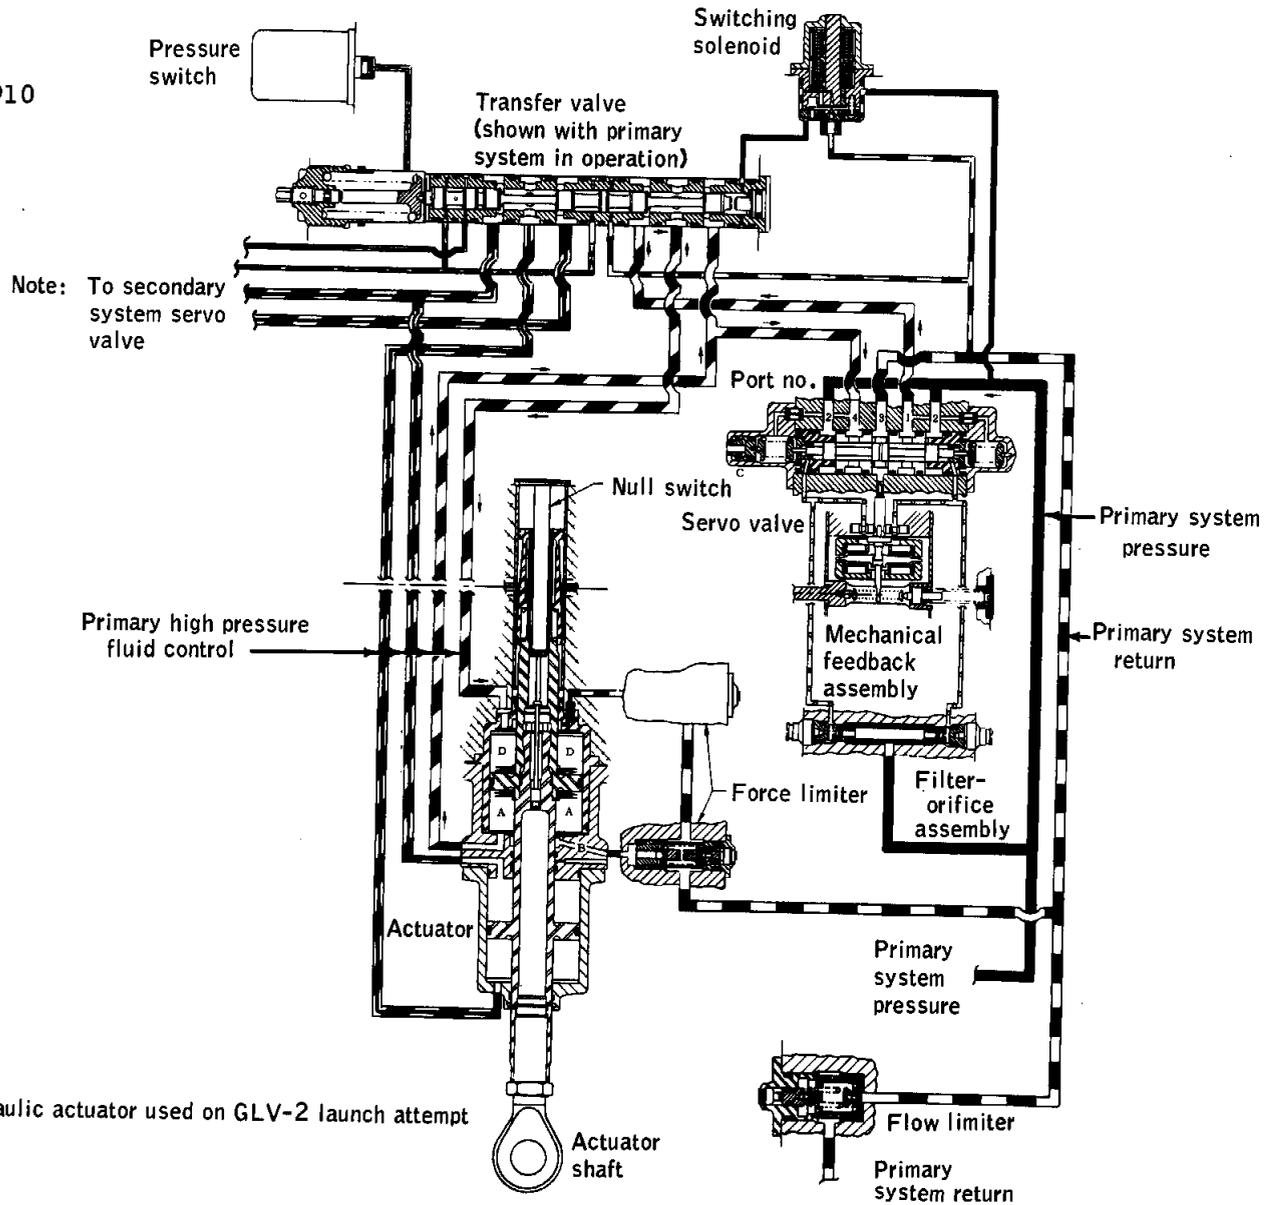
13.2.1.2 Servovalve failure analysis. - A routine metallurgical analysis of the servovalve housing disclosed some embrittlement of the 2014-T6 aluminum alloy. A structural analysis revealed that the mounting lug thickness should have been adequate for the design pressures. The bulk of the failure analysis effort was then directed toward systems analyses and systems tests. As a result of an extensive investigation by the contractor, involving the above mentioned analyses and tests, the following explanation of the failure was derived. Figure 13-4 shows a schematic of the hydraulic system. If an external

Figure 13-4. - Hydraulic actuator used on GLV-2 launch attempt

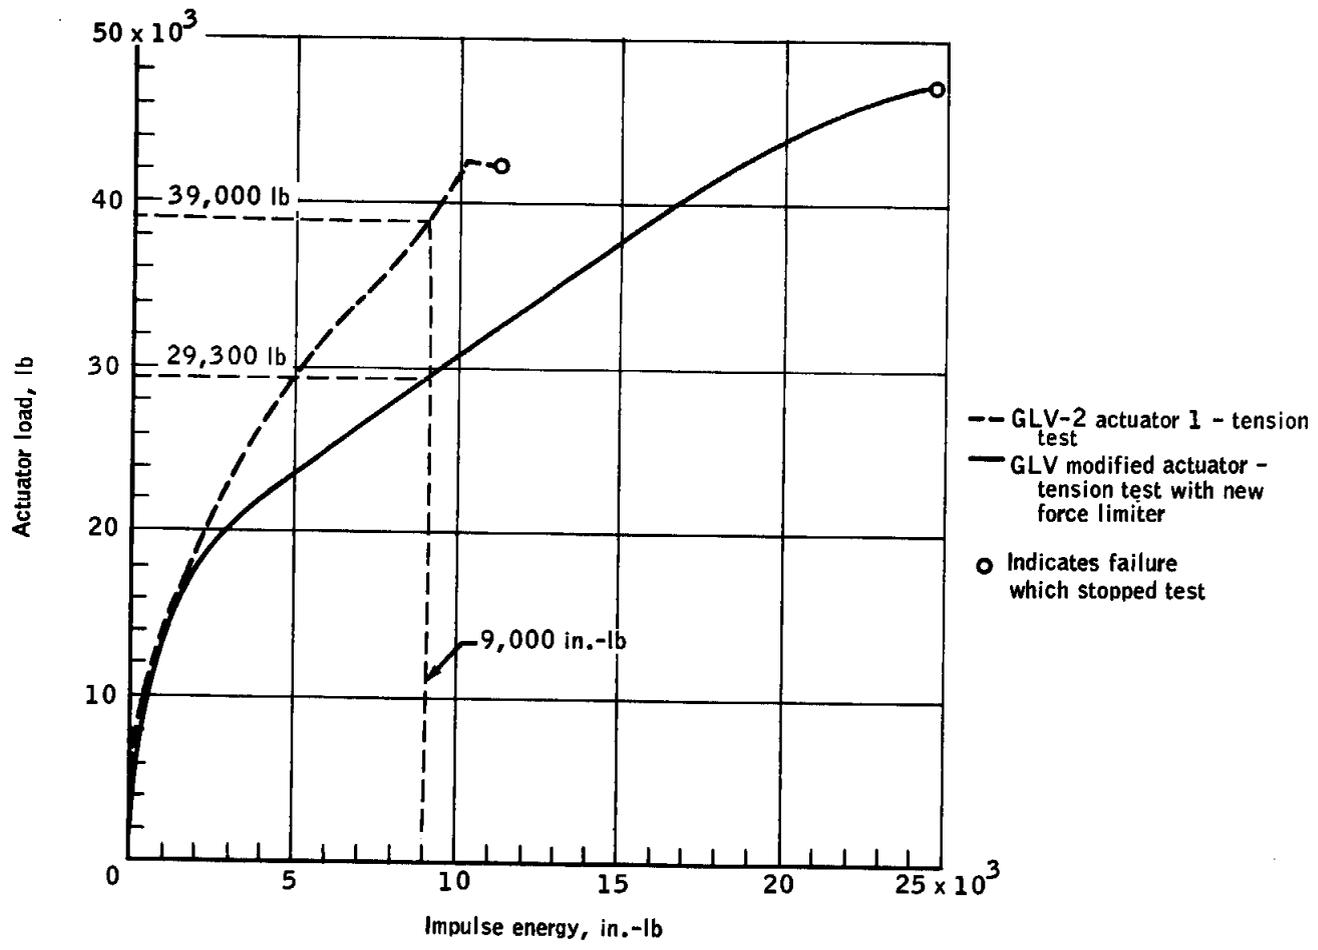
The modified actuators were subjected to impulse tests in which it was shown that their impulse energy absorption characteristics were increased over those of the original actuator. The improvement achieved with the modified actuator is shown in figure 13-5. This figure shows the capability of the unmodified and modified actuator to absorb impulse energy. For example, for an impulse of 9000 in.-lb, a load of 39 000 pounds was produced across the unmodified actuator. For the same impulse loading, the modified actuator load is reduced to 29 300 pounds. The basic capability of the actuator to take impulse loading before failure was increased by a factor of 2. Further, it

Figure 13-5. - Impulse energy capability of modified and unmodified actuators

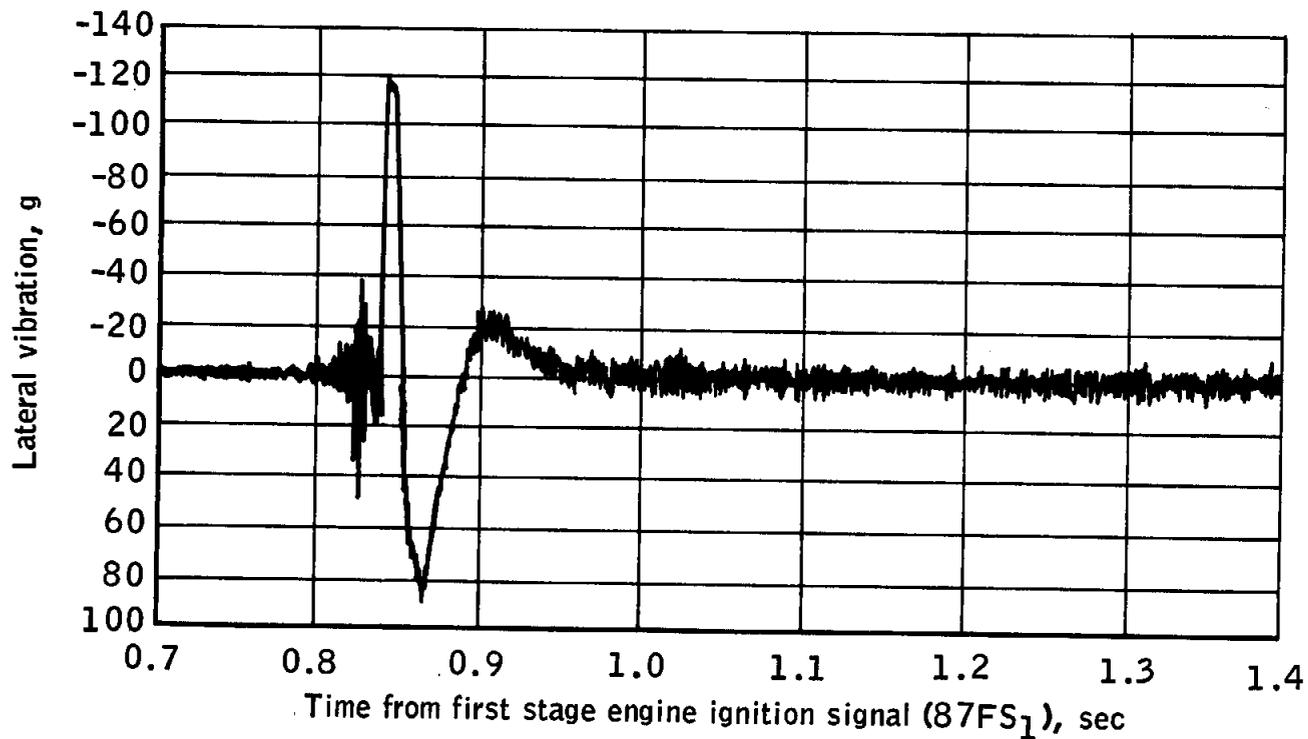
One point of interest concerning the launch attempt is the indicated output of the lateral vibration sensor located on the actuator which failed (yaw-roll actuator 2_1 on subassembly 2). The peculiar waveform generated by this transducer, shown in figure 13-6, is typical of an output caused by a high-g shock input and has been confirmed by laboratory tests on an identical airborne system. Since this pickup was located very near the region of failure on the 2_1 actuator, its output behavior very strongly suggests that it was caused by the impact of the servovalve housing of the inside of the actuator tailstock housing at the exact time of failure.

Figure 13-6. - Stage I tandem actuator vibration
