**RESULTS OF THE SECOND  
U.S. MANNED  
SUBORBITAL SPACE FLIGHT  
JULY 21, 1961**

**MANNED SPACECRAFT CENTER  
NATIONAL AERONAUTICS  
AND SPACE ADMINISTRATION**

## FOREWORD

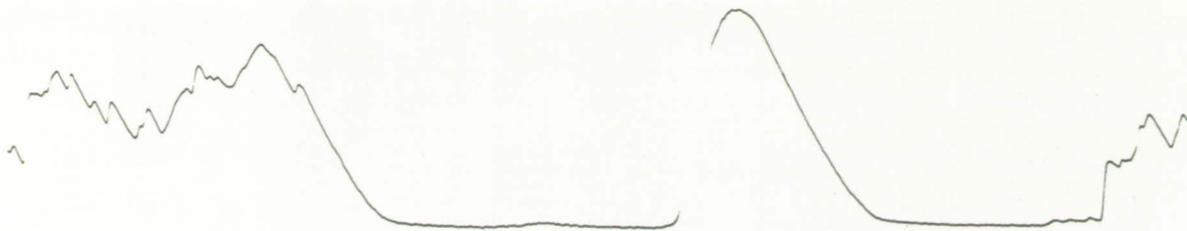
Respiratory trace. (Some variations represent speech)

ECG trace 1 (Axillary - small amplitude displacements due to muscle movement)

ECG 2 (Sternal) Showing sinus tachycardia

Body temperature trace  
(99.2°F)

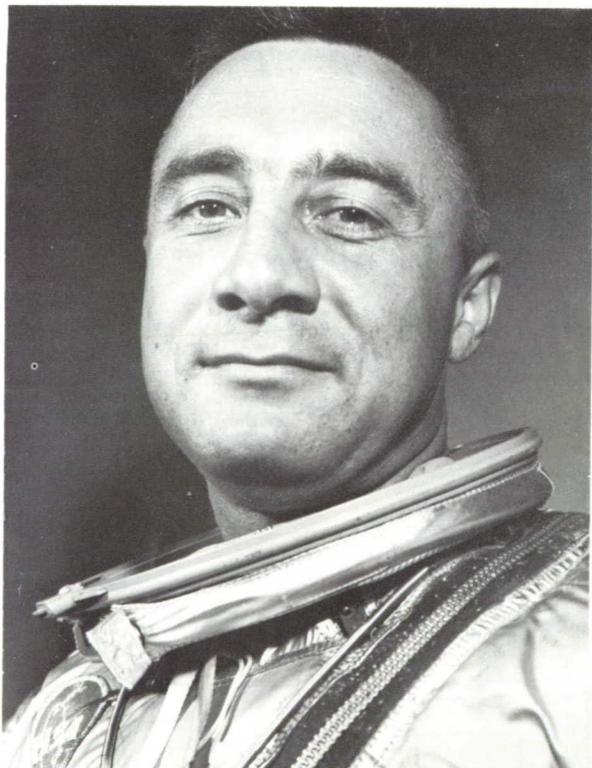
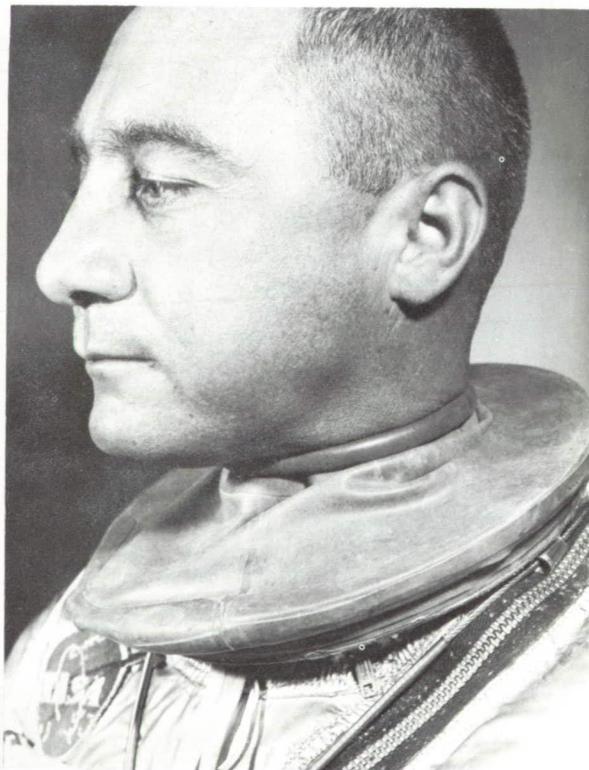
(a) Normal stored position.

(b) Unrolled position.

FIGURE 7-6. Neck dam.
